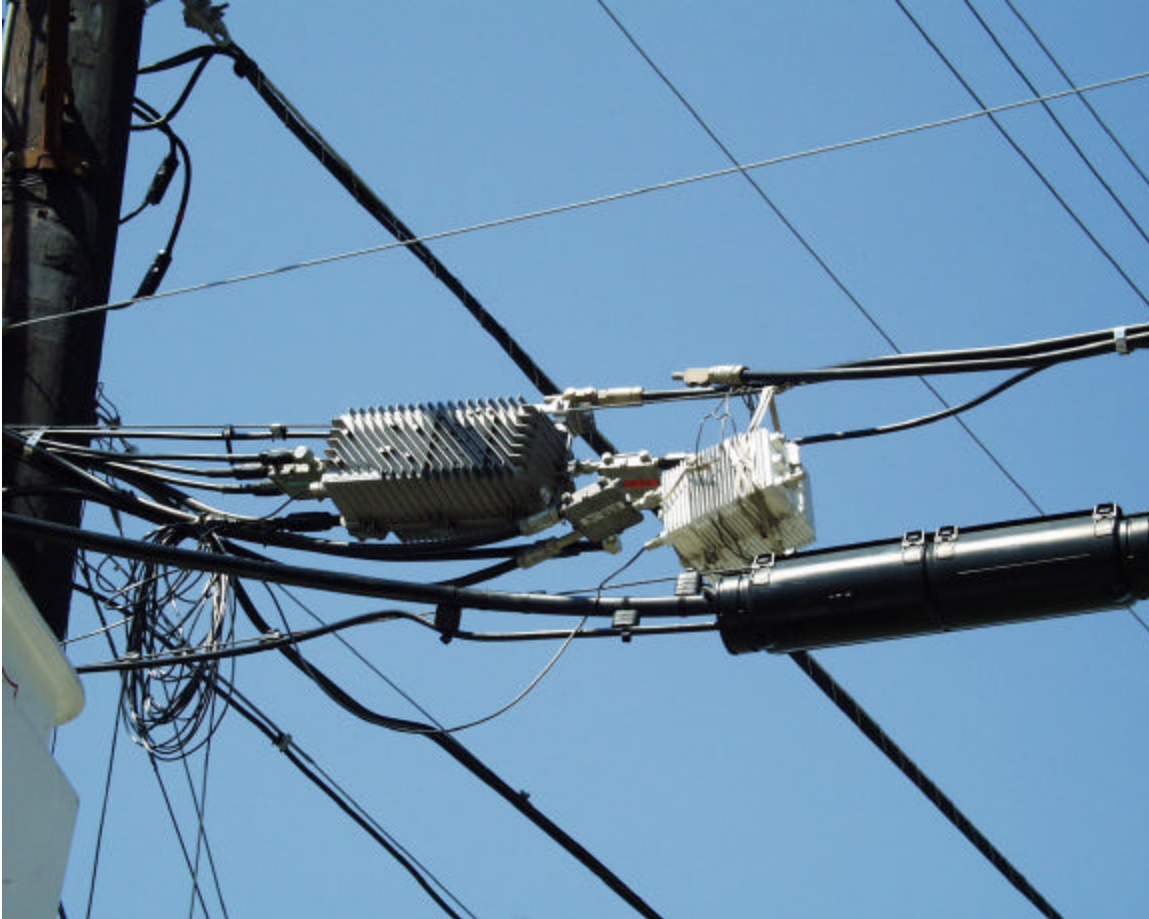
The above photograph was taken at the intersection of W Street, S.E. and Shanon Place, S.E. on May 3, 2000. It shows two fiber optic nodes, also referred to as transition nodes. These nodes accept signals carried as light over fiber optics and transform them into electrical signals to feed to coaxial cables. The white housing was the node that has been serving this section of the District. The housing to the left is the new node currently being installed.

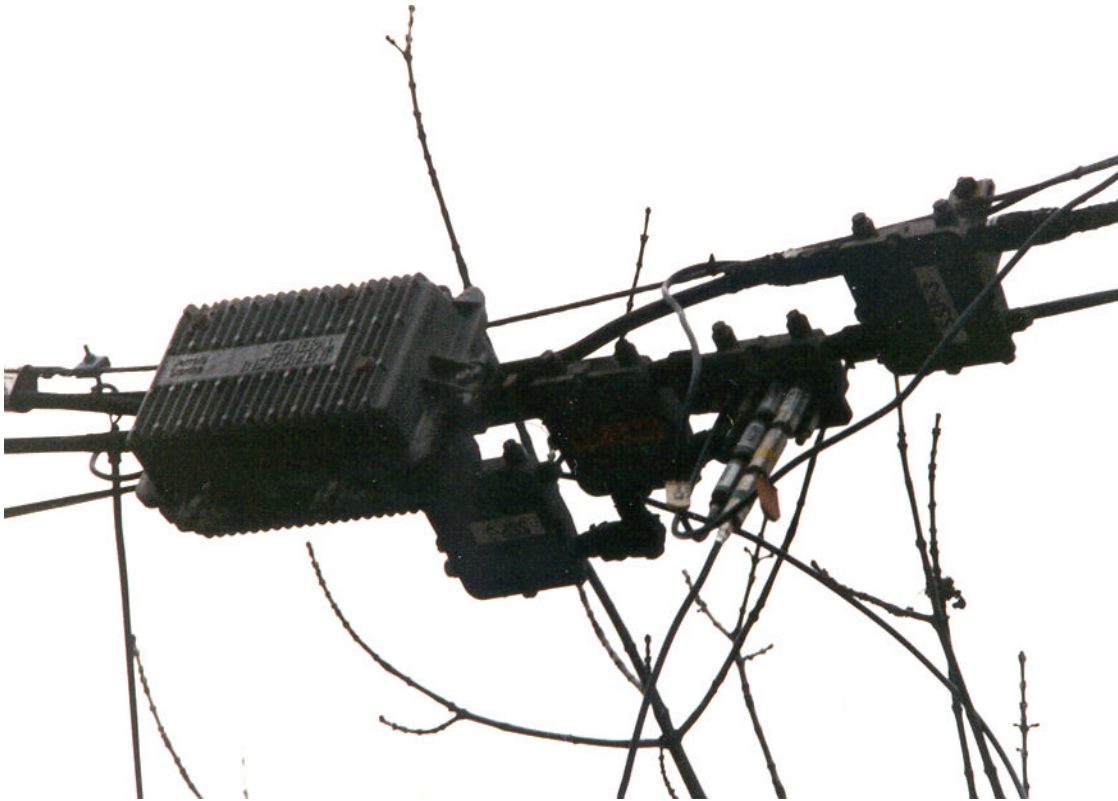
The above photograph, taken in 1998, shows some typical equipment found in a cable television distribution system. The large housing at the left is an amplifier; the two small square boxes with cables hanging down from them are subscriber taps; the small round cylinders hanging from the subscriber taps are filter traps; and the remaining two square items are splitters.

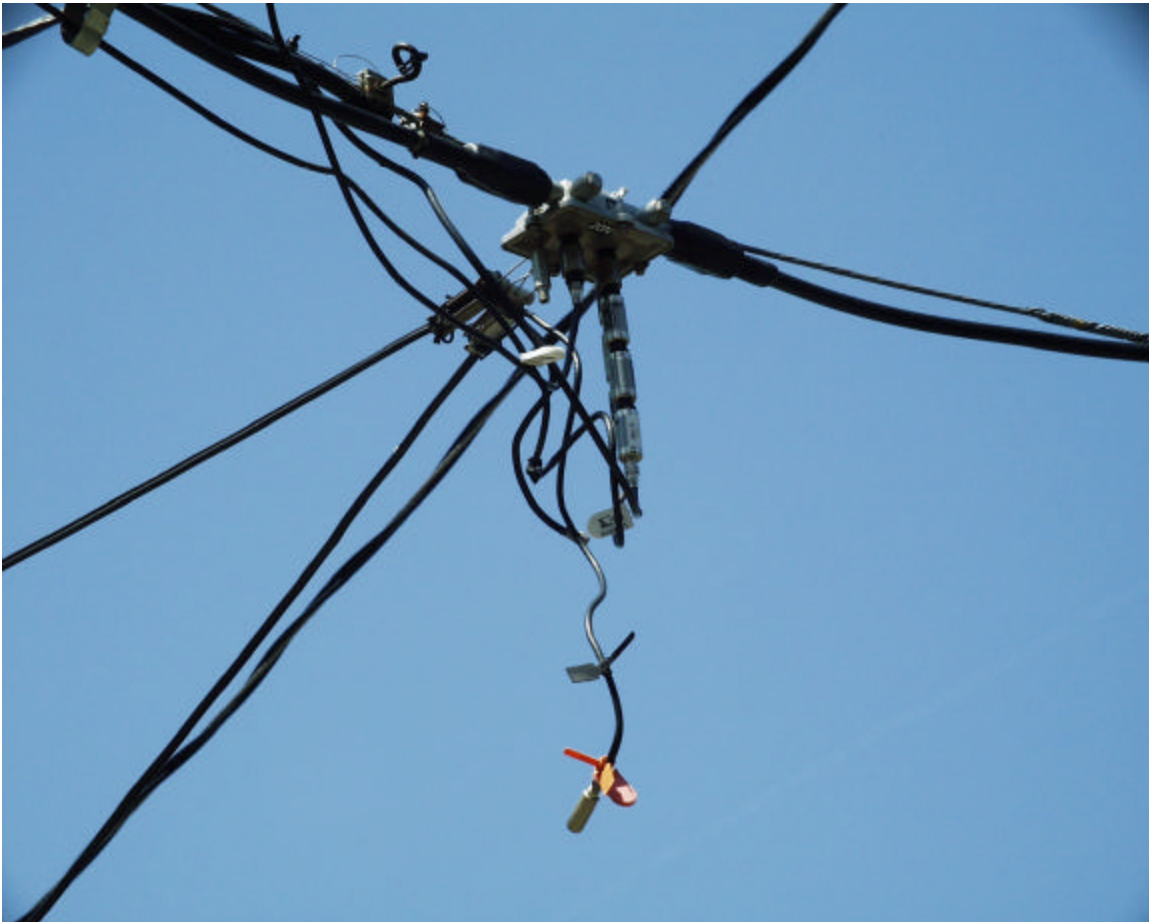
The above photograph was taken near the intersection of Chicago Street, S.E. and Railroad Avenue, S.E. on May 3, 2000. The square box is a subscriber tap; the small round cylinders hanging from the subscriber tap are filter traps.

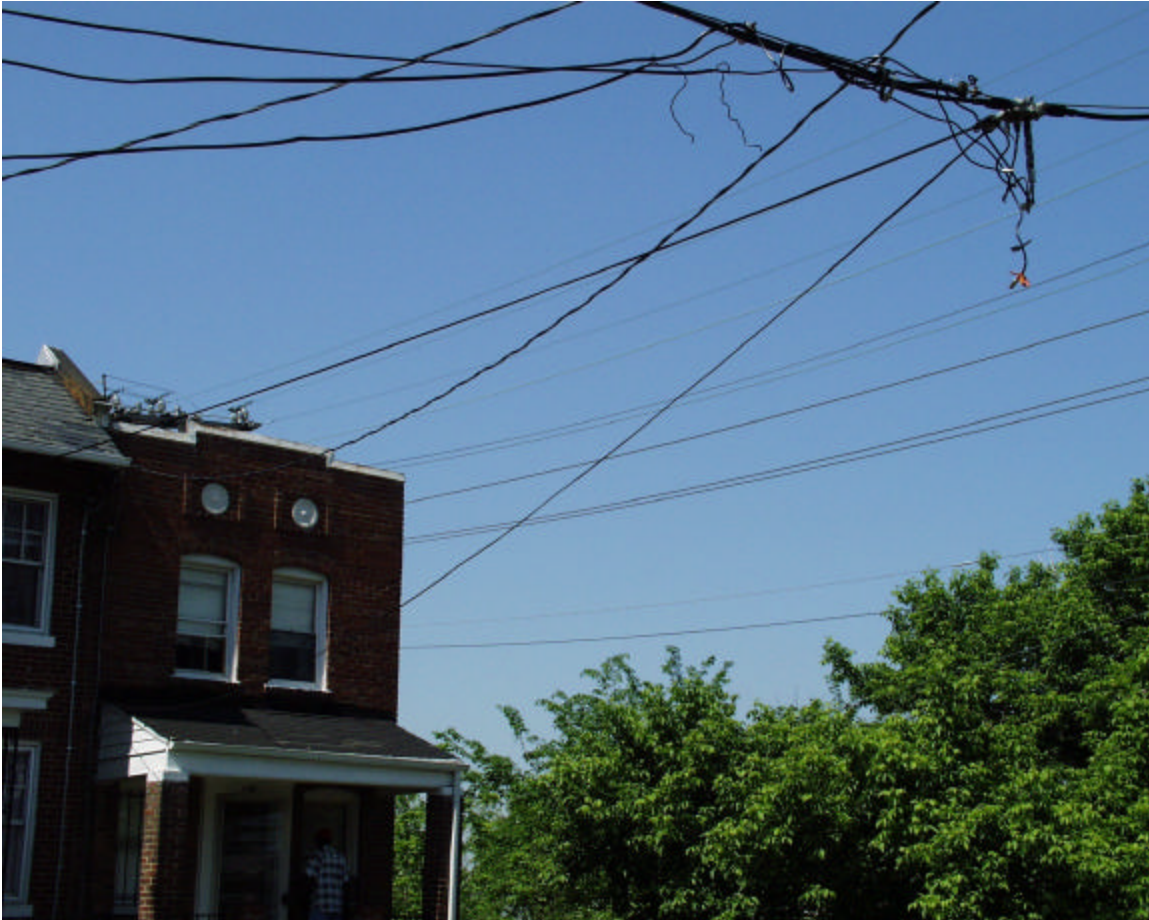
The above photograph was taken near the intersection of Chicago Street, S.E. and Railroad Avenue, S.E. on May 3, 2000. The subscriber tap in the upper right hand corner is the same subscriber tap as was shown in the preceding photograph. This photograph shows the cable going across the street to the house. This is typically referred to as a drop.

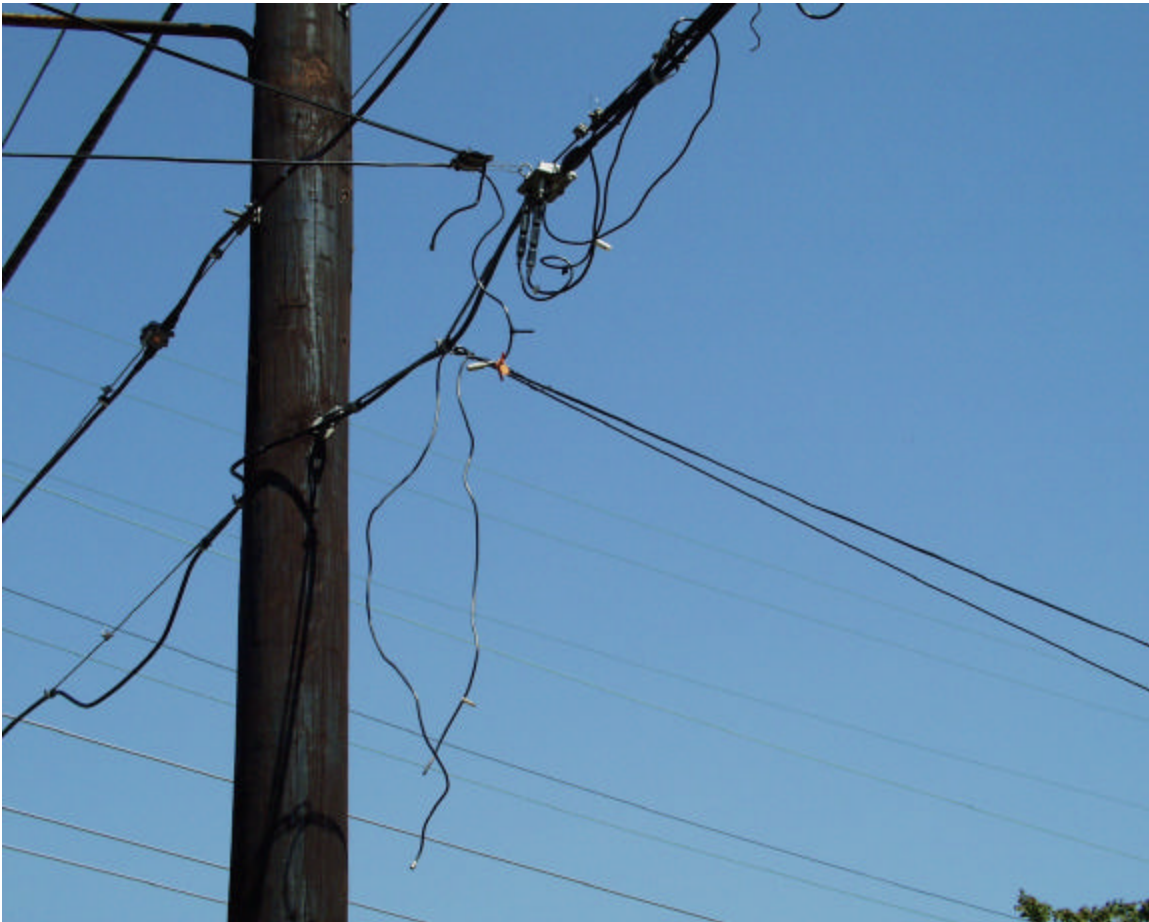
The above photograph was taken near the intersection of Chicago Street, S.E. and Railroad Avenue, S.E. on May 3, 2000. The square box is a subscriber tap; the small round cylinders hanging from the subscriber tap are filter traps. It shows a different subscriber tap than shown in the preceding photographs.

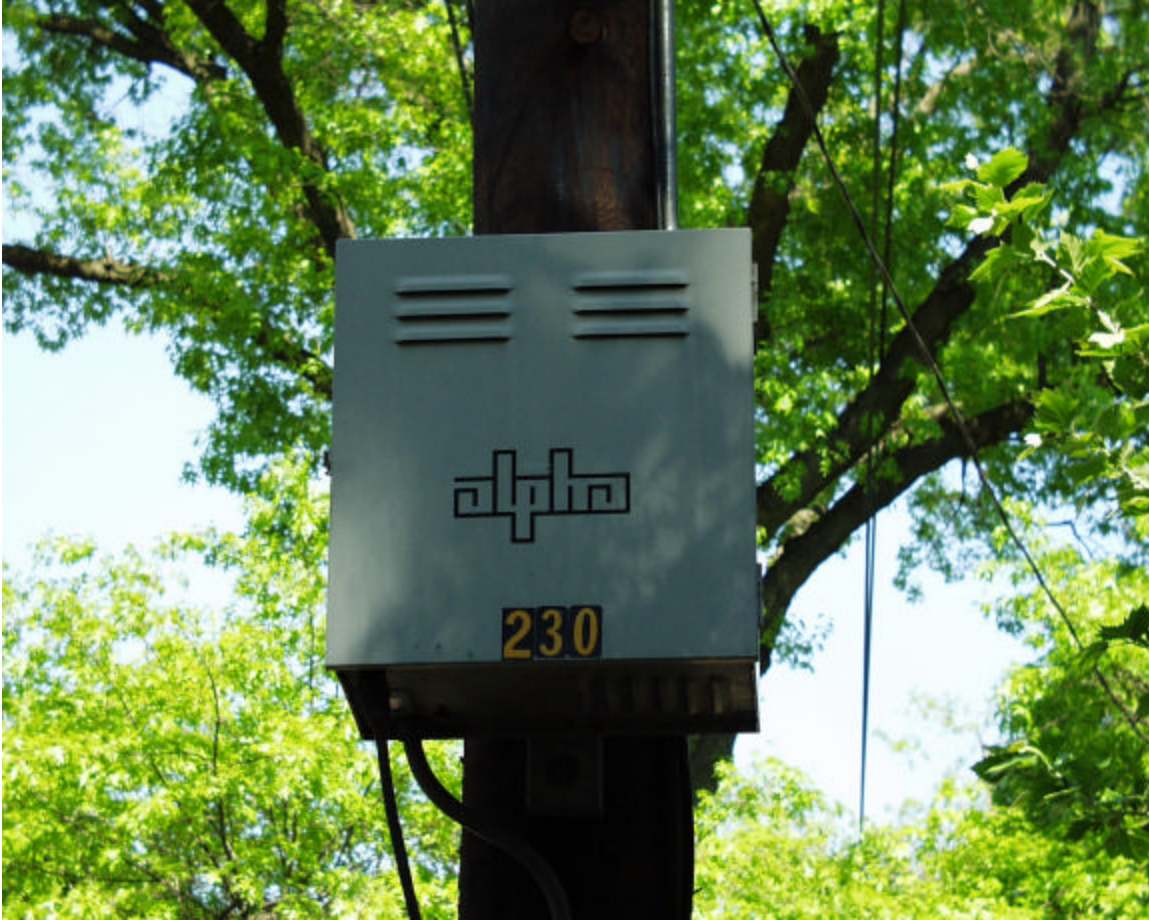
The above photograph was taken near the intersection of 13th Street and Lawrence Street, N.E. on May 3, 2000. It shows an aerial mounted power supply.

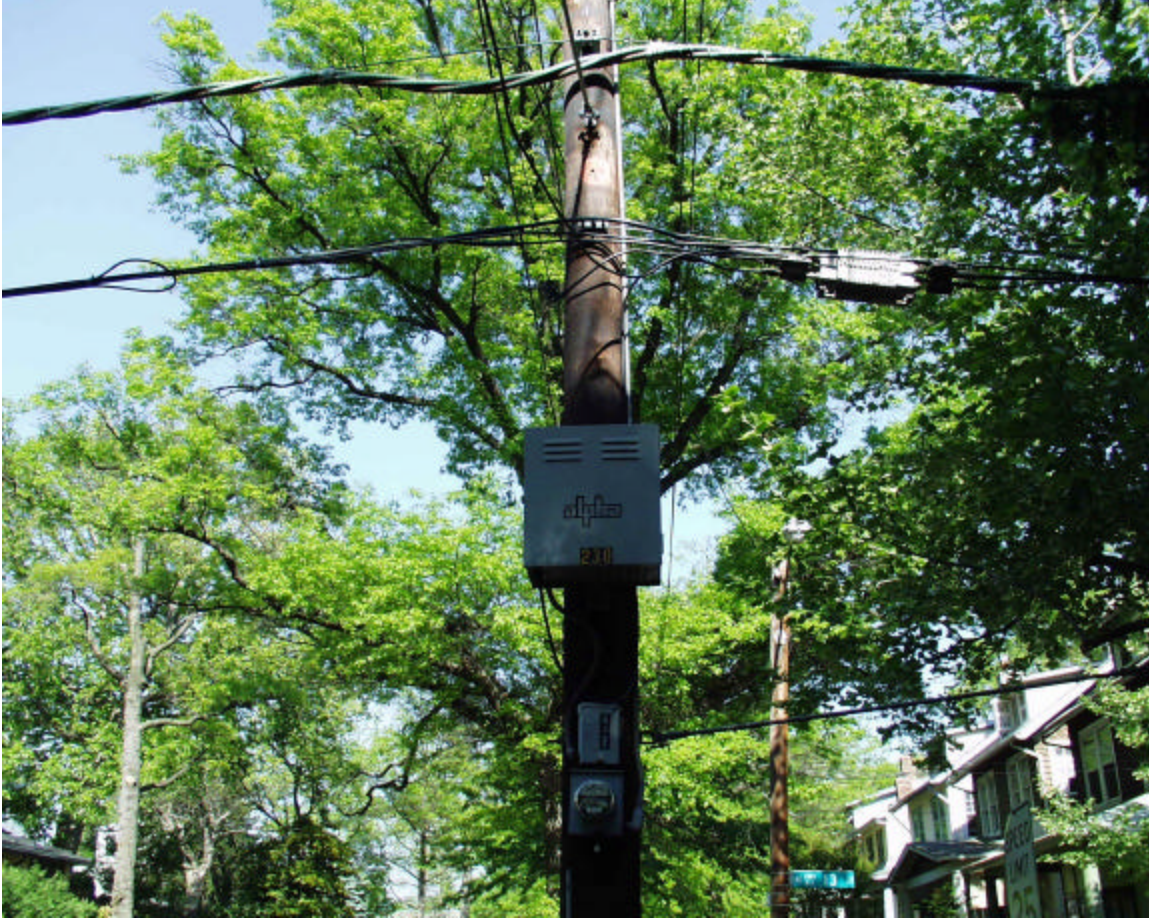
The above photograph was taken near the intersection of 13th Street and Lawrence Street, N.E. on May 3, 2000. It shows a further view of the aerial mounted power supply shown in the previous photograph, along with electrical power meter below it and the distribution system coaxial cable amplifier in the upper right hand corner.

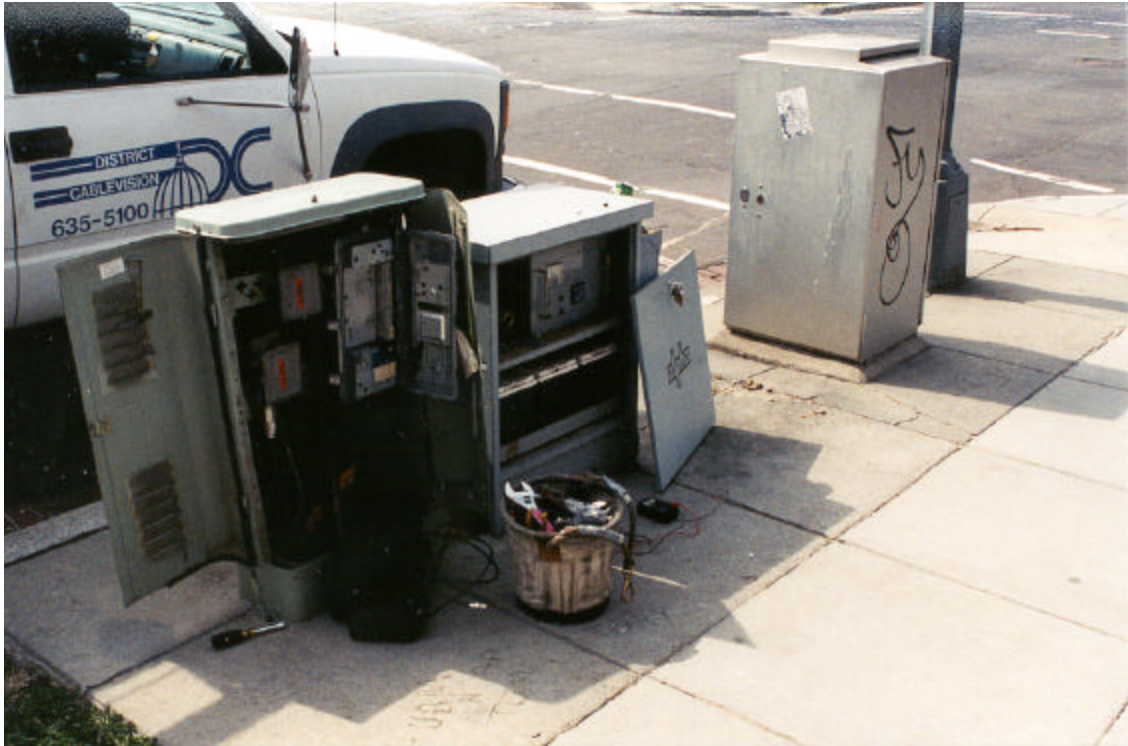
The above photograph was taken in the downtown area near the White House circa 1998. The open pedestals show an example of how amplifiers and power supplies are used in an underground section of the distribution system. A coaxial cable amplifier and splitters can be seen in the left hand pedestal; and the power supply along with backup batteries are in the right hand pedestal.

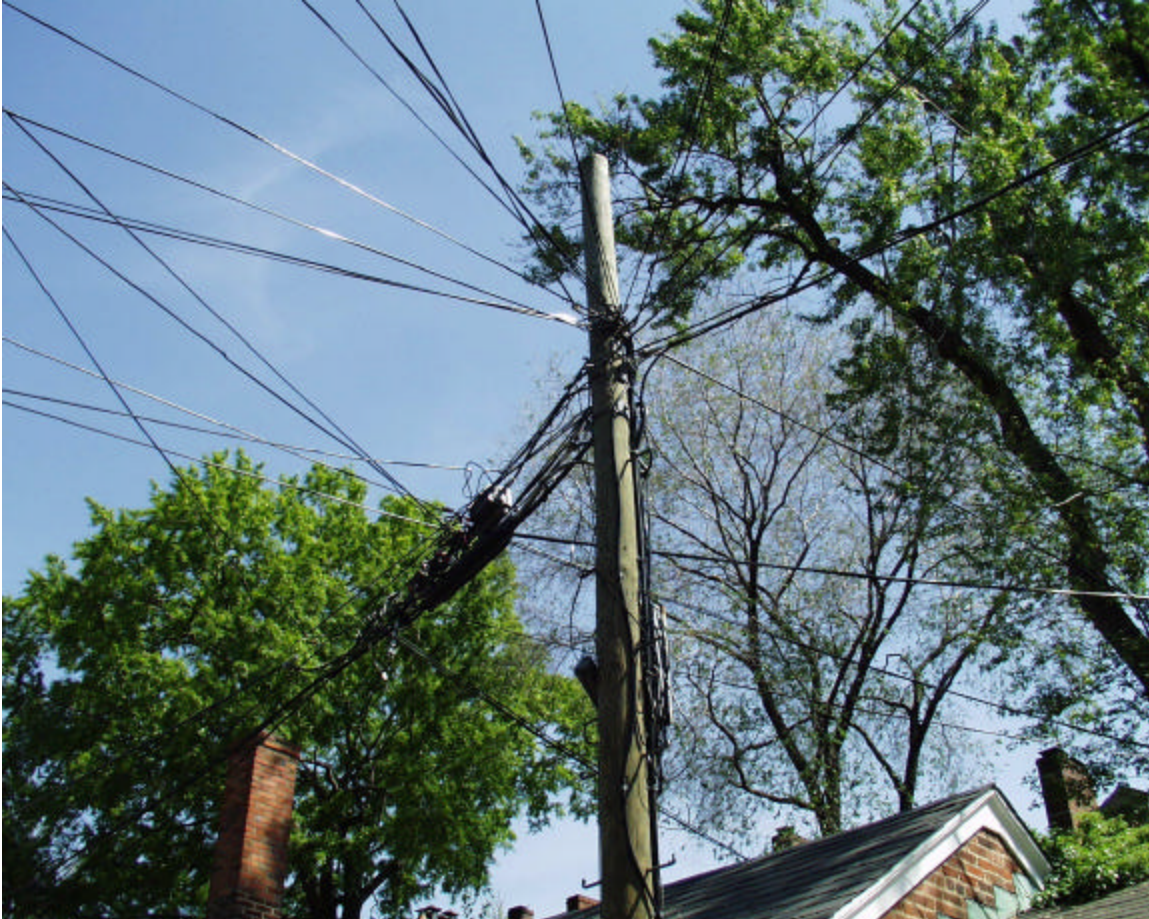
The above photograph was taken in an alley at 33rd Street between N and O Streets, N.W. on May 3, 2000. It shows an overall view of the aerial distribution system and contains a coaxial cable amplifier, subscriber taps, and drop cables to the residences.

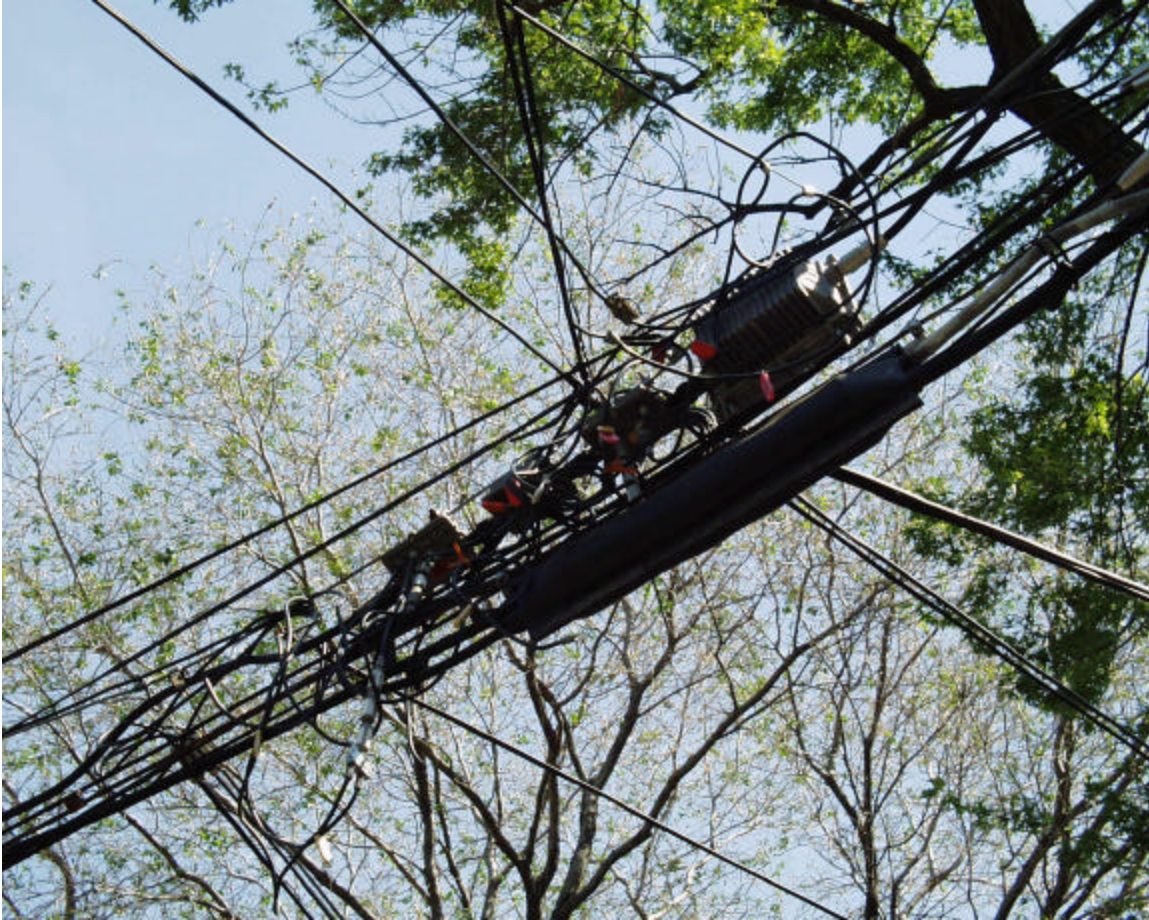
The above photograph was taken in an alley at 33rd Street between N and O Streets, N.W. on May 3, 2000. It is a closer view of a portion of the preceding photograph to better show the subscriber taps, filter traps, and coaxial cable amplifier.

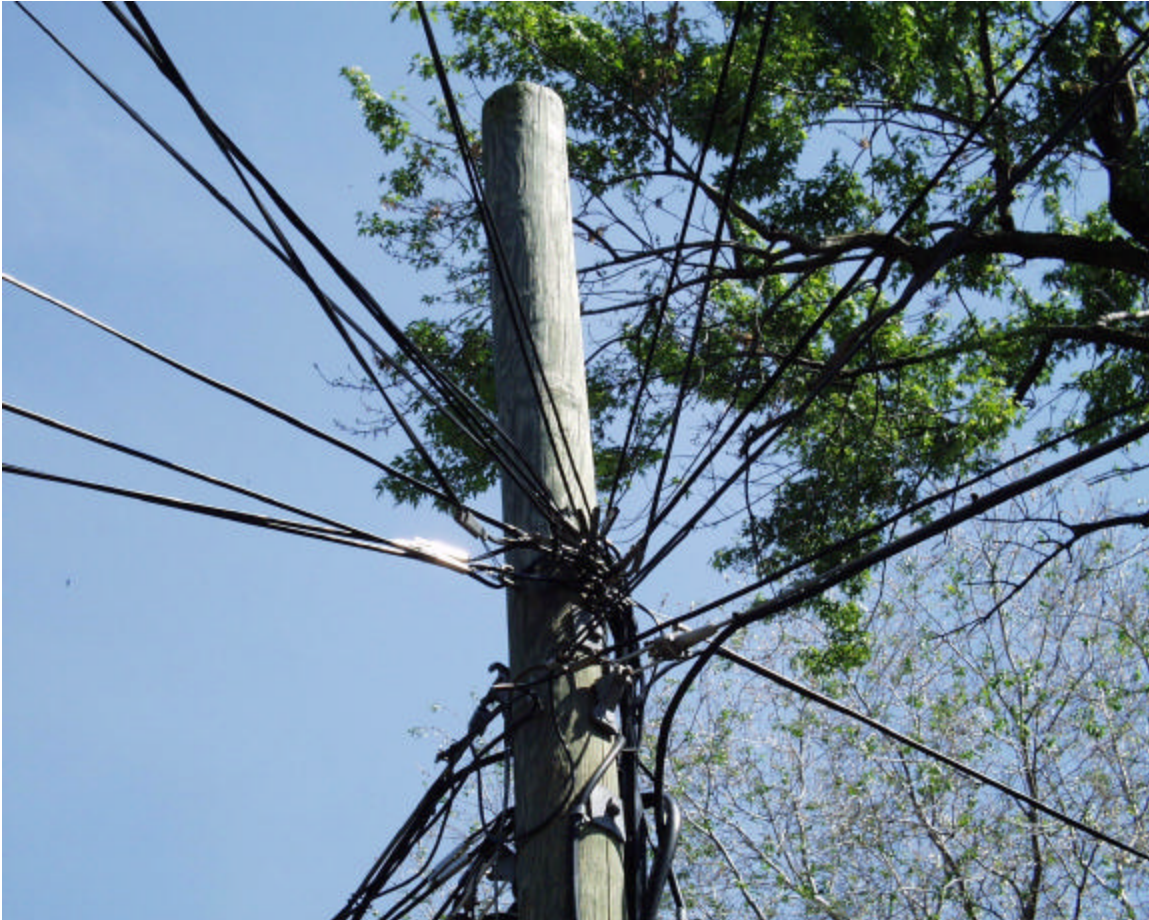
The above photograph was taken in an alley at 33rd Street between N and O Streets, N.W. on May 3, 2000. It is a closer view of a portion of the same location as seen in the two preceding photographs to show how drop cables are attached to the pole.

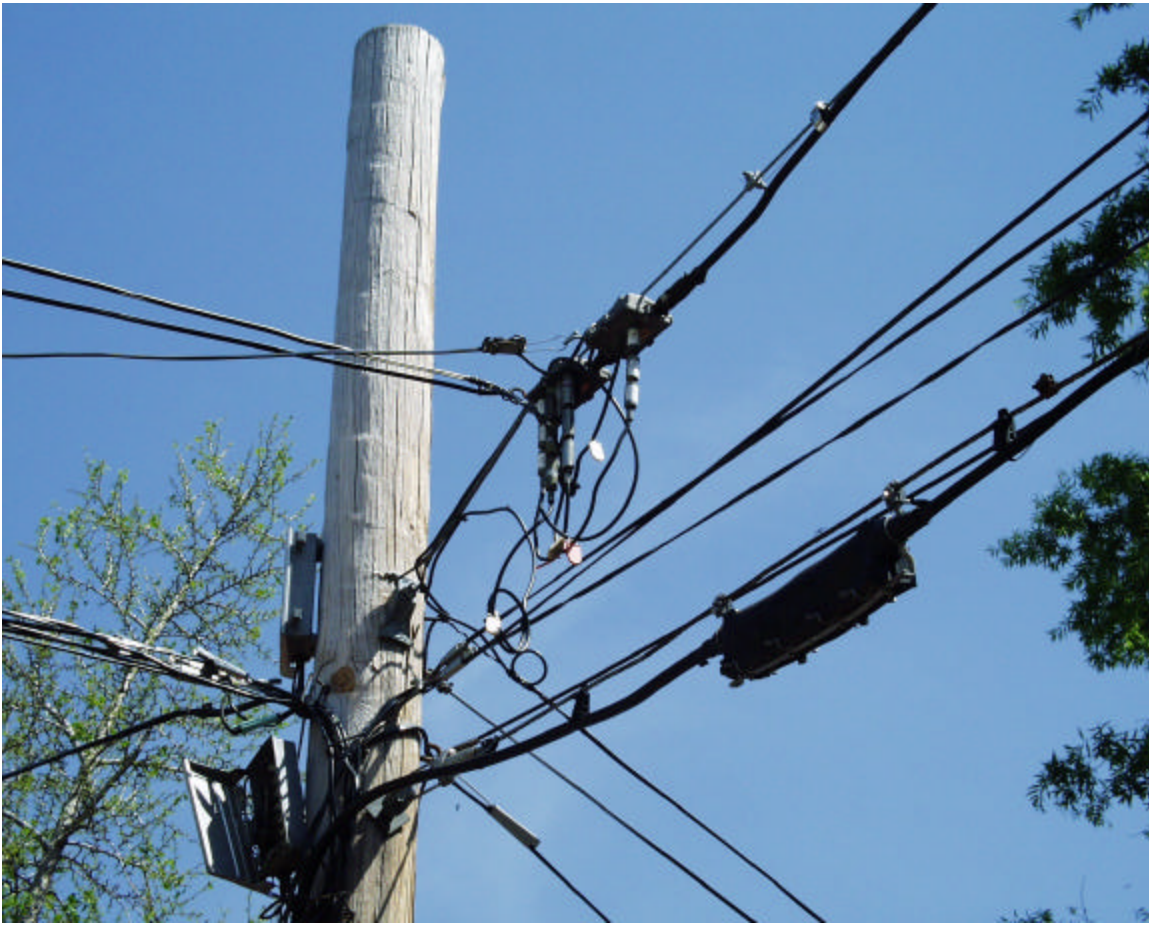
The above photograph was taken in an alley at 33rd Street between N and O Streets, N.W. on May 3, 2000. It is at a different location in the alley than was shown in the preceding three photographs. It shows subscriber taps and filter traps from the cable television system, as well as telephone company related equipment.

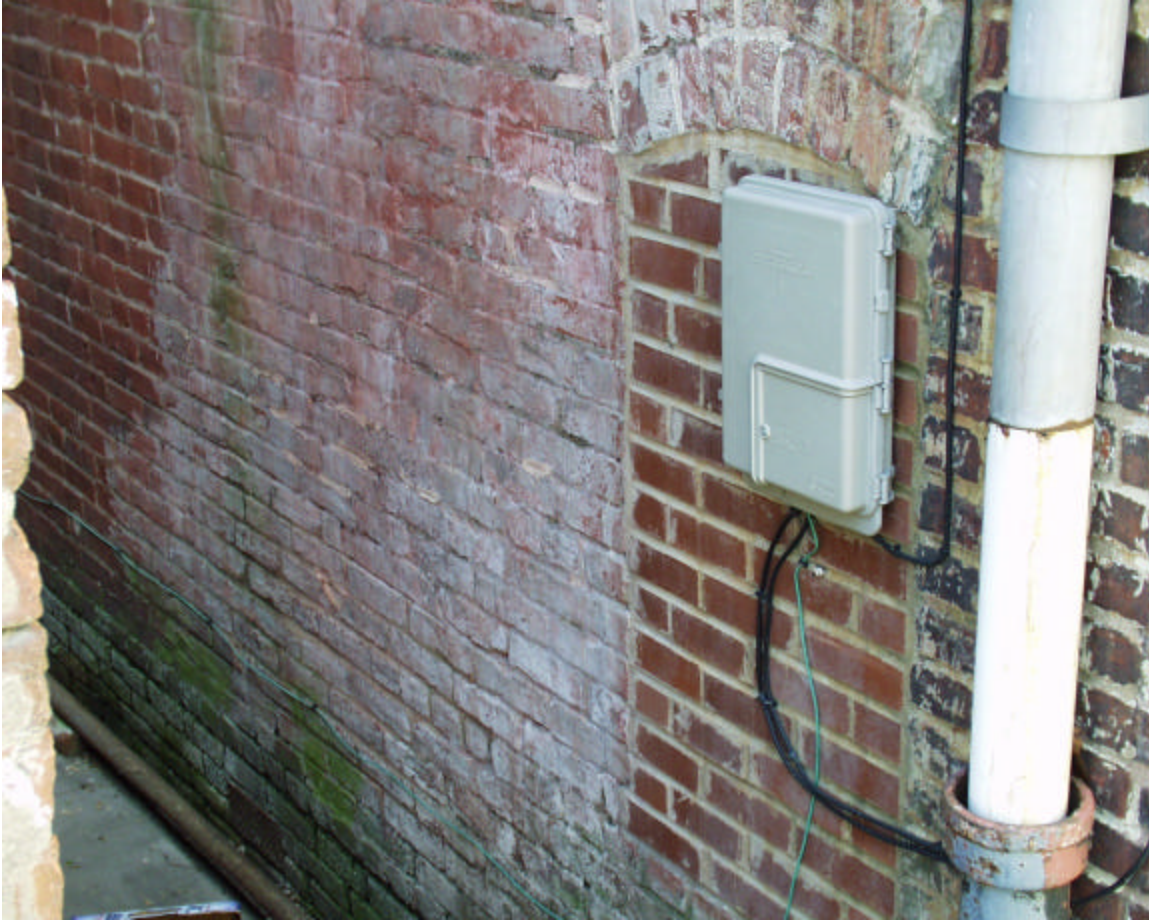
The above photograph was taken in an alley at 33rd Street between N and O Streets, N.W. on May 3, 2000. The SA box (made by a company called Scientific Atlanta) shown is mounted on the back wall of a building at 1301 33rd Street, N.W. and contains equipment to couple the subscriber drop cable to the building coaxial cables. A ground block coupler/splitter is included in the SA box that connects to the green wire leaving the box going to a building electrical ground point and coaxial cables going to cable television outlets in the building.

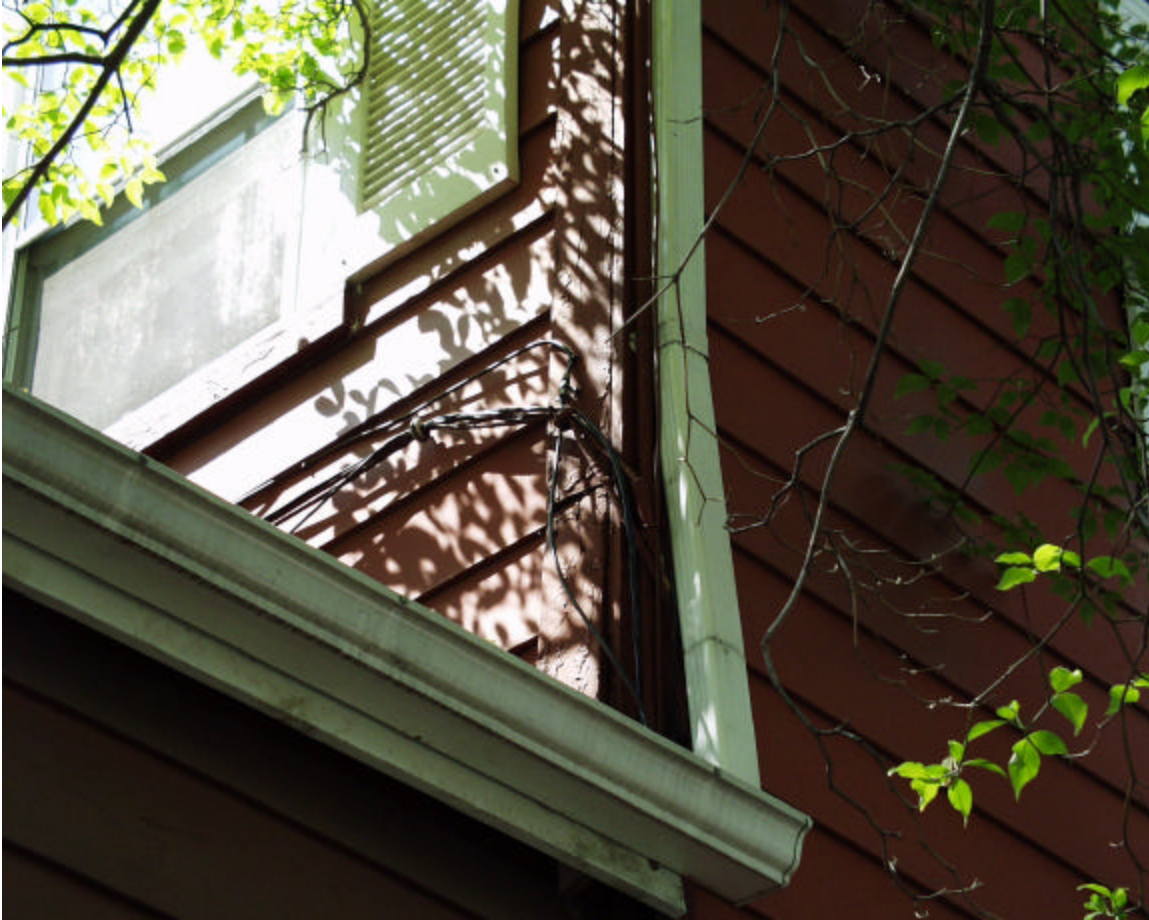
The above photograph was taken at 3248 O Street, N.W. on May 3, 2000. It shows the coaxial cable from the subscriber drop and what appears to be a ground block coupler.

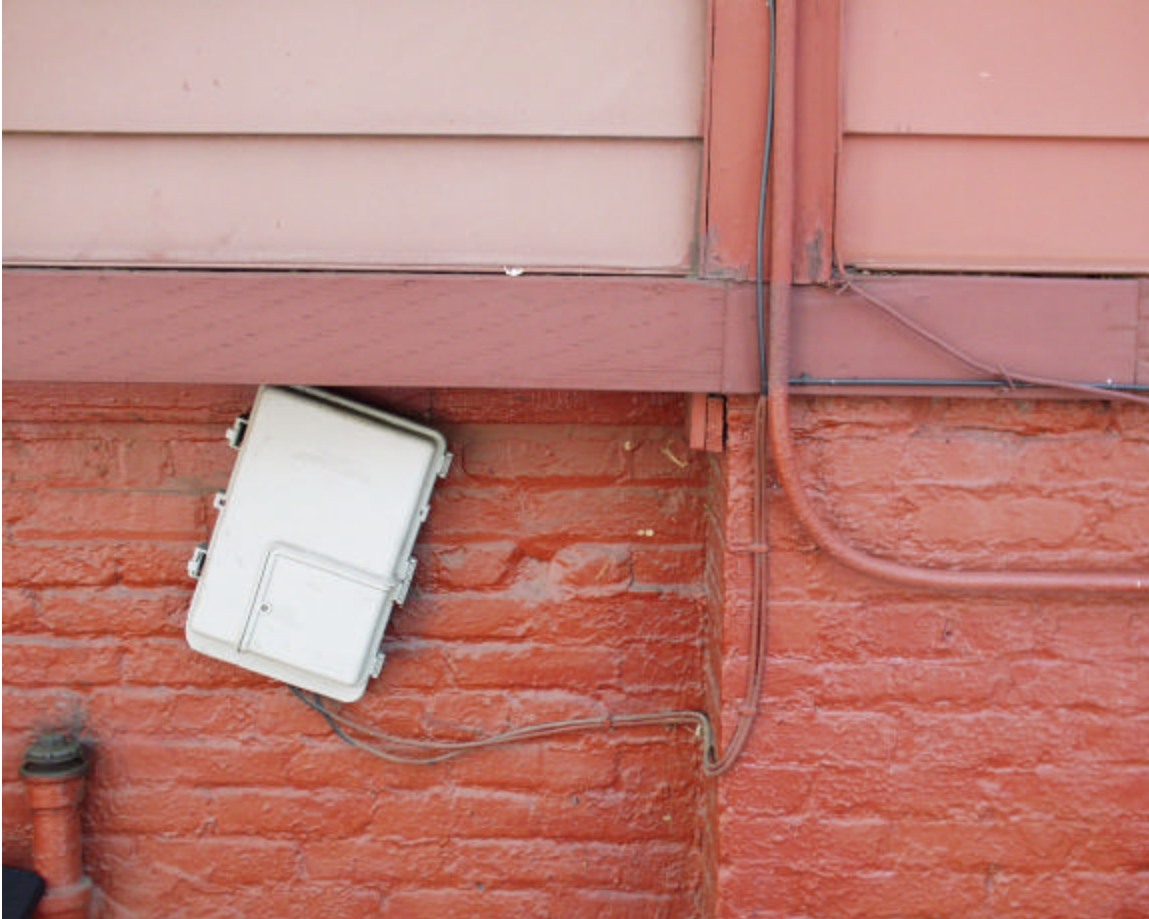
The above photograph was taken at 3248 O Street, N.W. on May 3, 2000. The SA box (made by a company called Scientific Atlanta) shown is serving as a connection point for the two coaxial cables, one of which comes from the location shown in the preceding photograph. The other wire to the right coming from above appears to be the ground wire coming from the ground block coupler shown in the previous photograph.

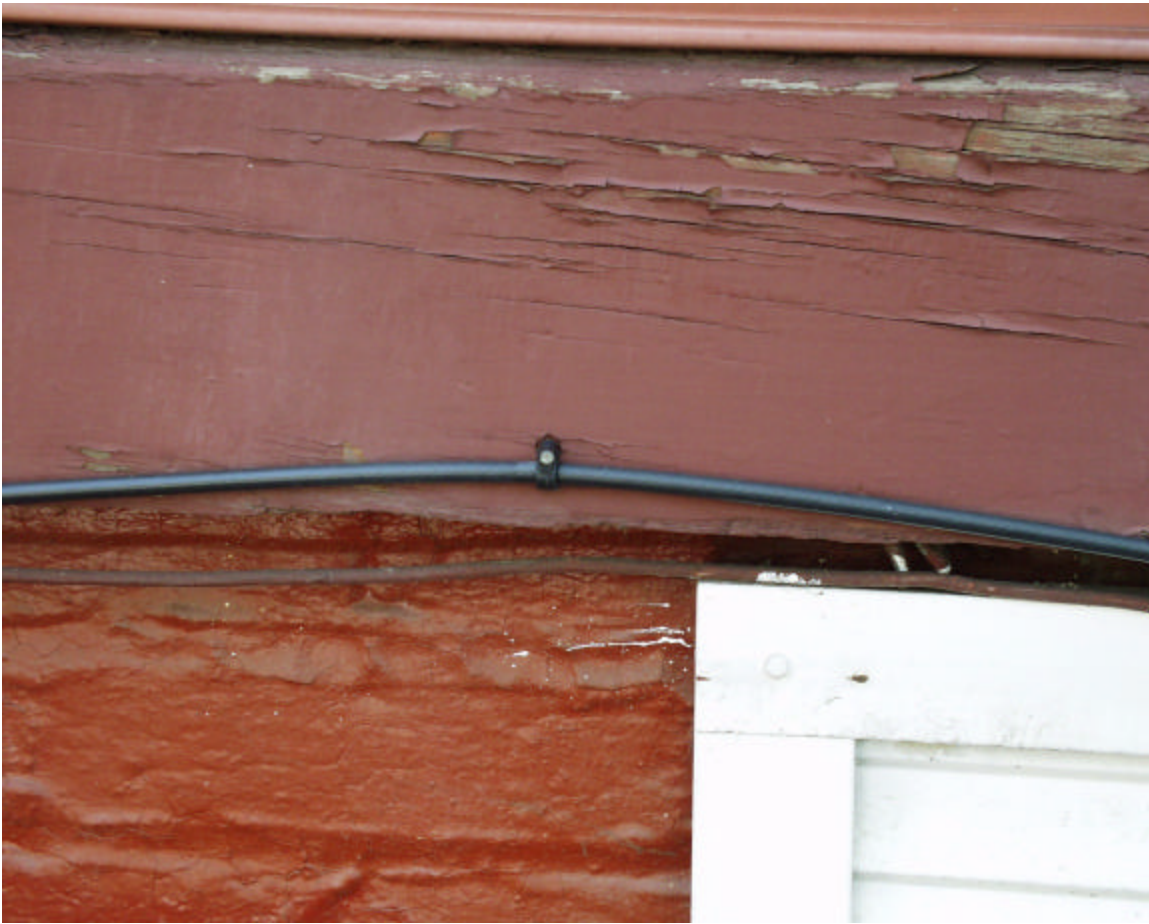
The above photograph was taken at 3248 O Street, N.W. on May 3, 2000. It shows the coaxial cable (upper cable) going to a cable television outlet in the building and a wire that appears to be the ground wire shown in the preceding two photographs and going to some undetermined electrical grounding point.

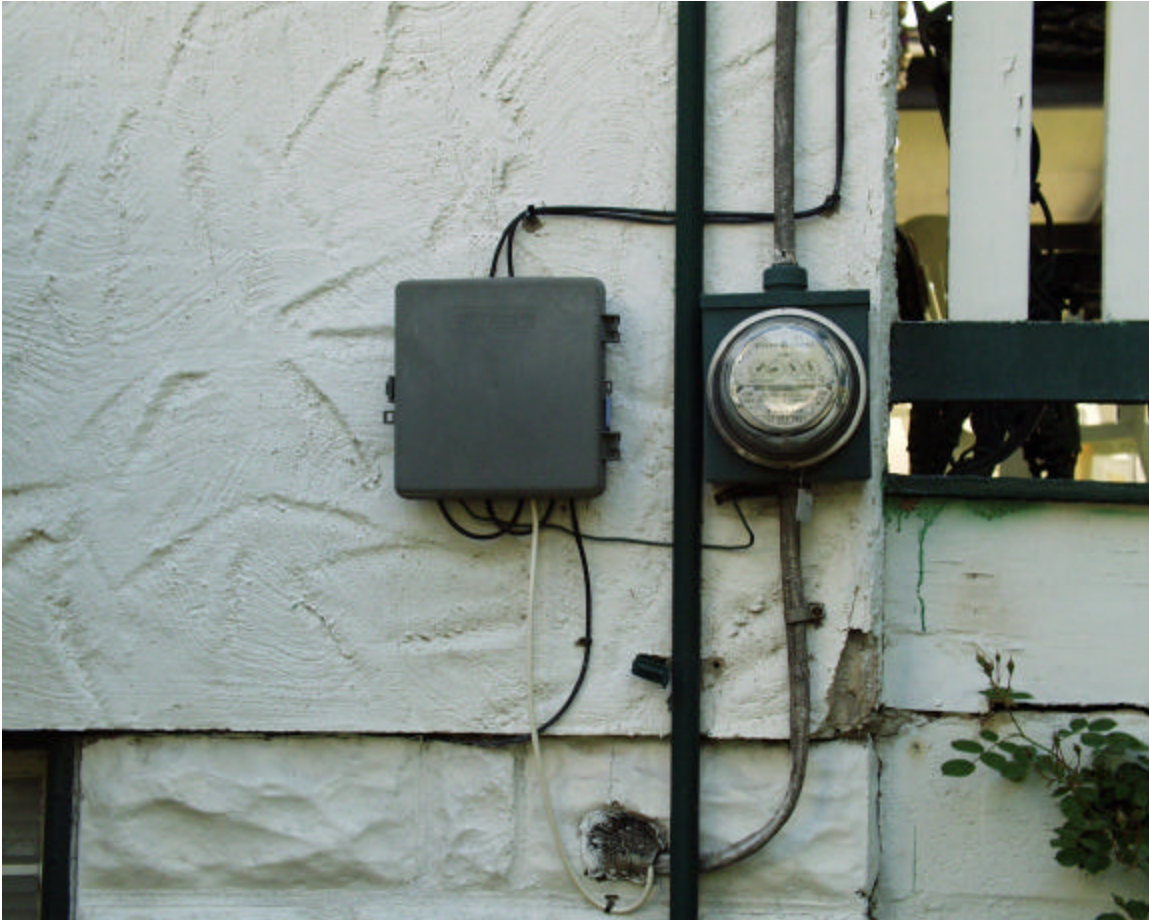
The above photograph was taken at 1257 Lawrence Street, N.E. on May 3, 2000. The SA box (made by a company called Scientific Atlanta) shown contains equipment to couple the subscriber drop cable to the building coaxial cables. A ground block coupler/splitter is included in the SA box that connects to the green wire leaving the box going to the electrical meter ground point and coaxial cables going to cable television outlets in the building.

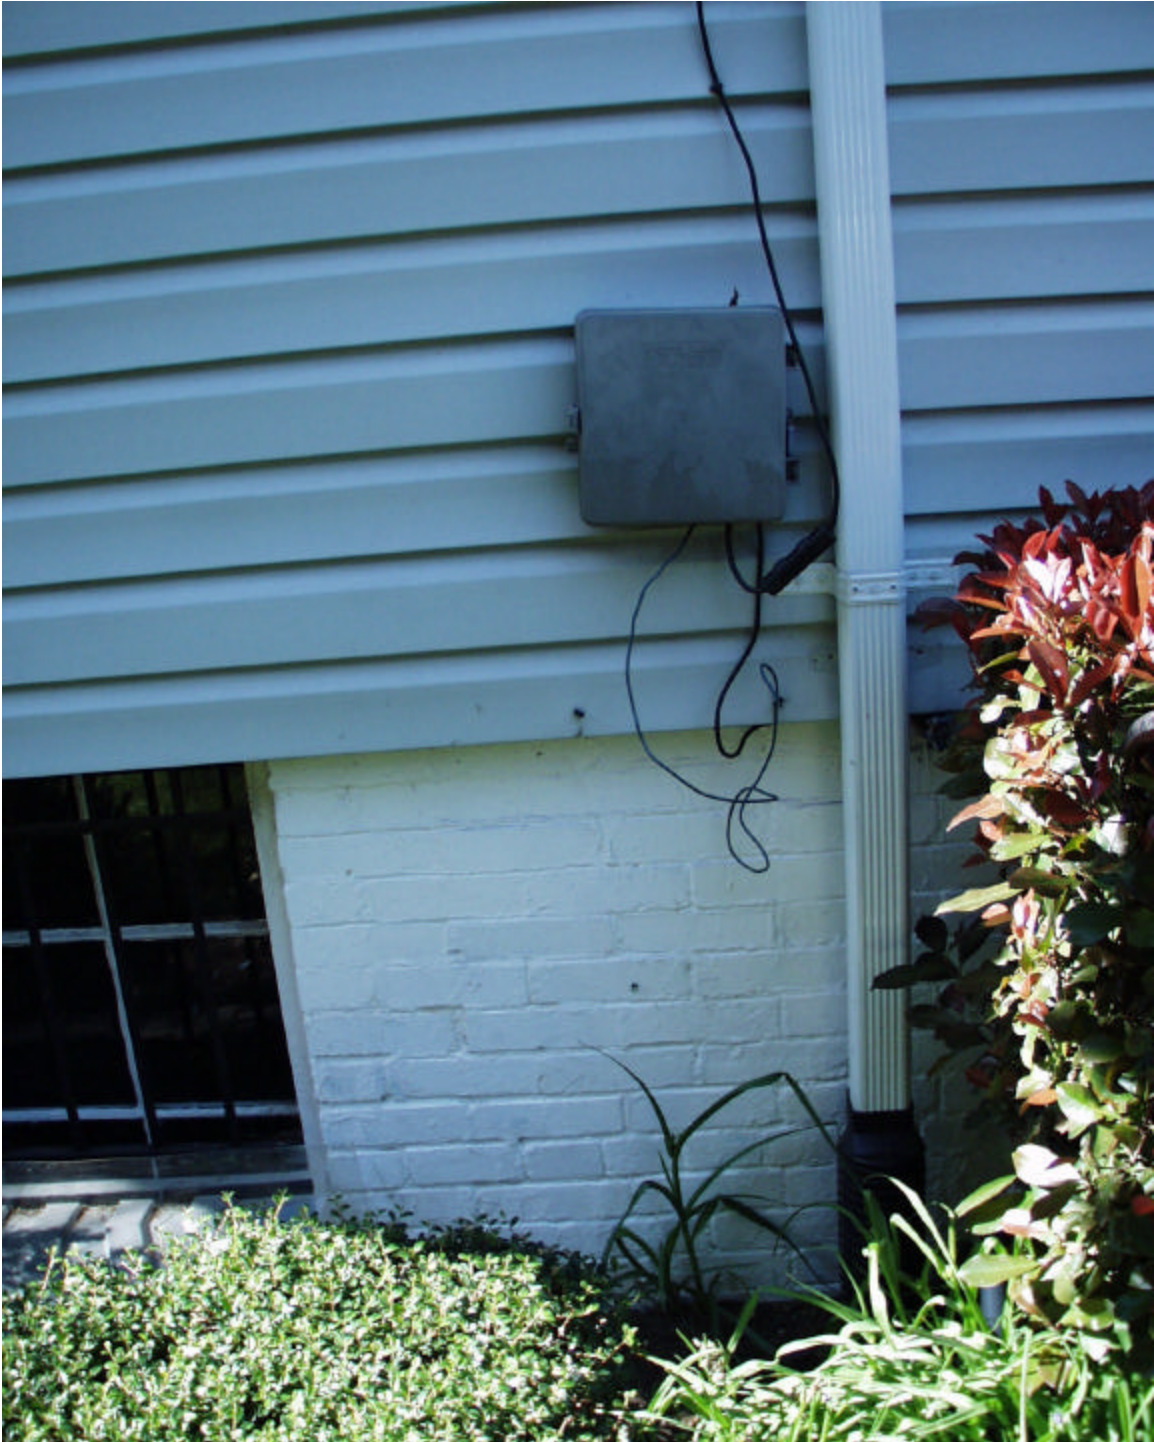
The above photograph was taken at 3326 13th Street, N.E. on May 3, 2000. A ground block coupler/splitter is included in the SA box that connects to the green wire leaving the box; it should go to electrical ground, but has

become disconnected. The coaxial cable goes to cable television outlets in the building.

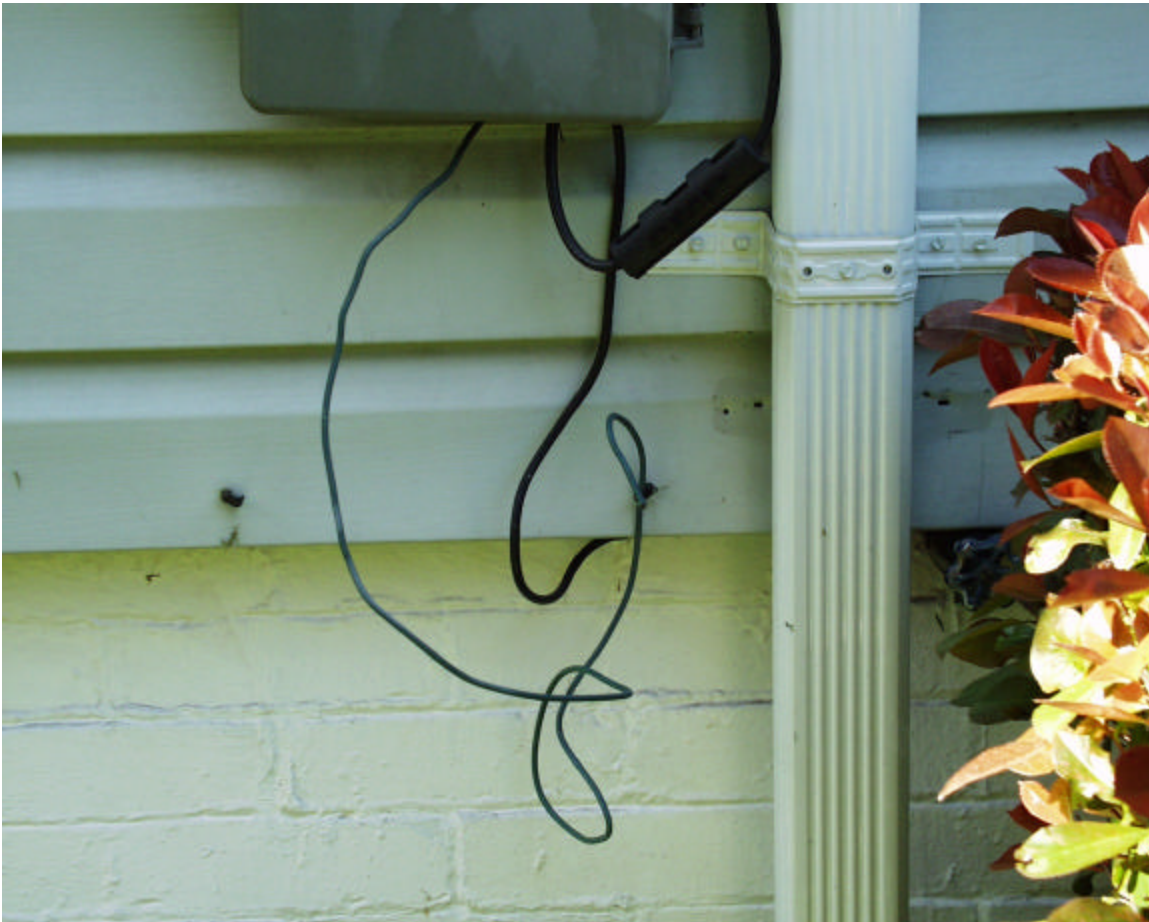
The above photograph was taken at 3326 13th Street, N.E. on May 3, 2000. It shows a closer view of the disconnected green wire leaving the box that should go to electrical ground.

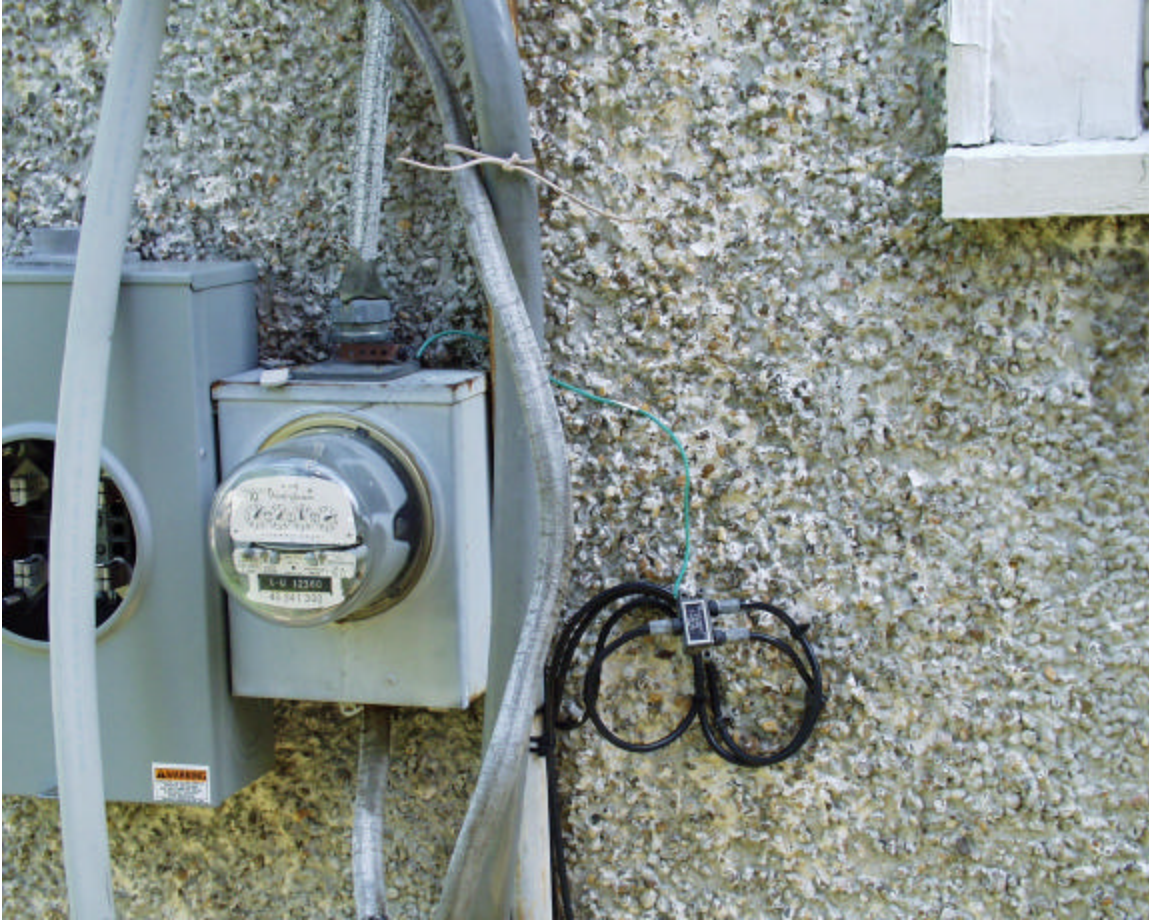
The above photograph was taken at 3316 13th Street, N.E. on May 3, 2000. It shows a ground block coupler/splitter. The green wire leaving the ground block coupler connects to the electrical meter ground point and the coaxial cables go to cable television outlets in the building.
