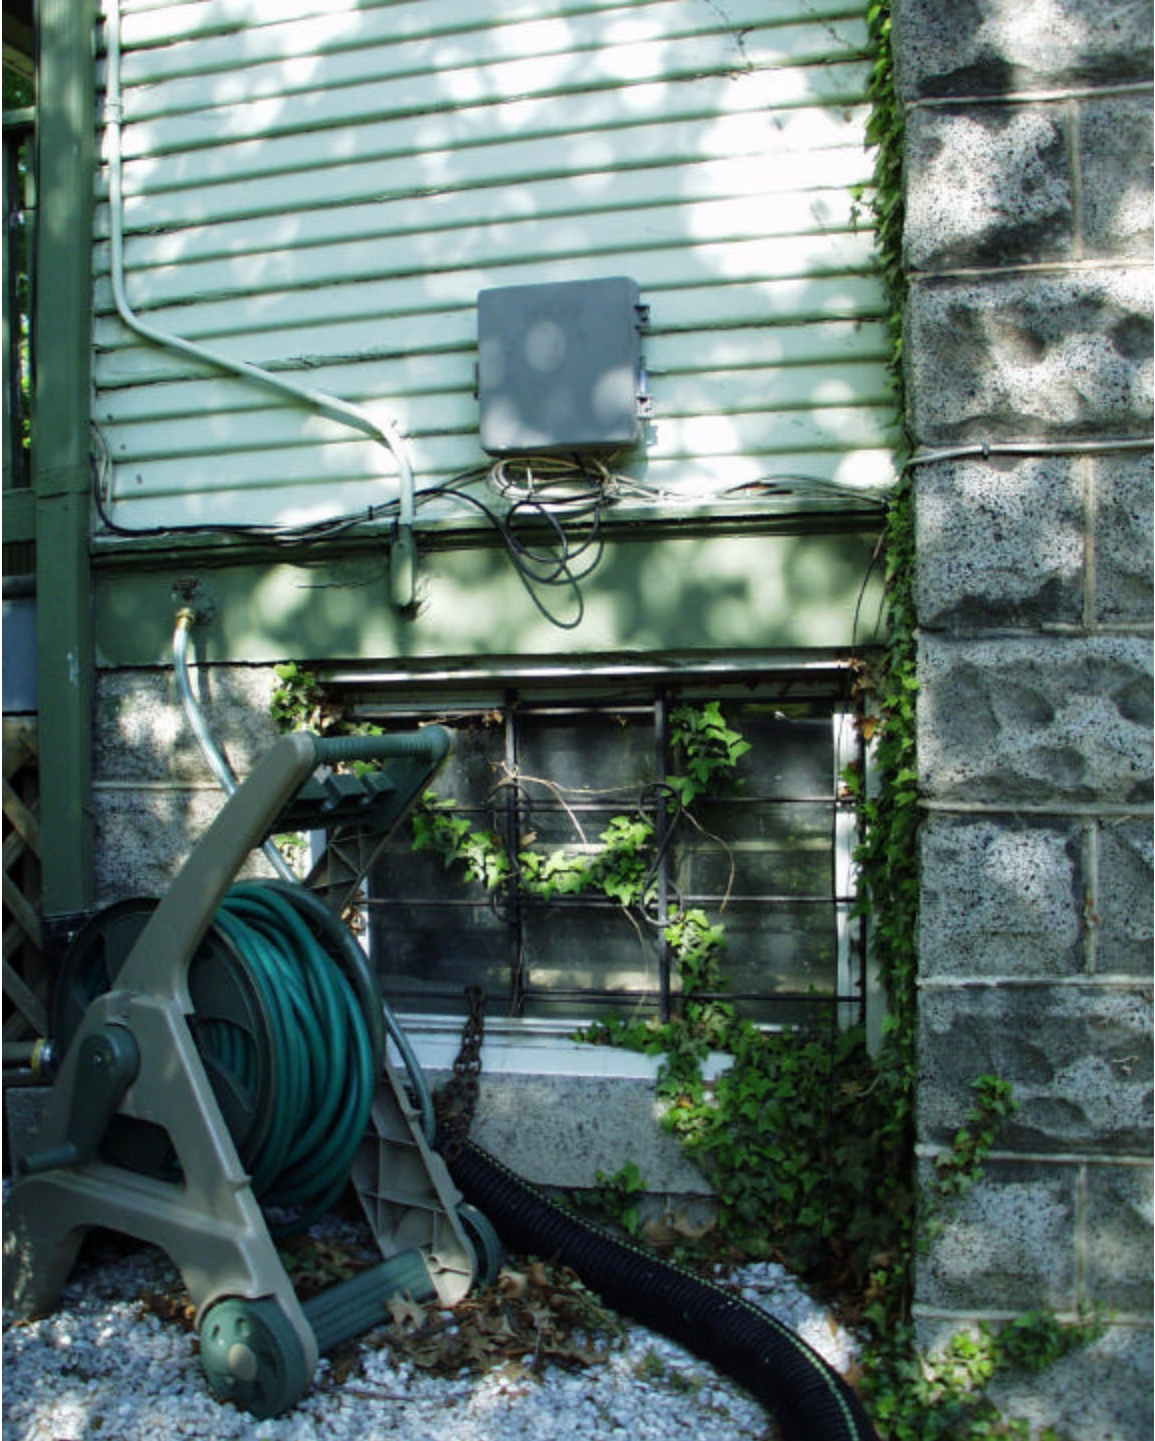
The above photograph was taken at 1301 Lawrence Street, N.E. on May 3, 2000. The SA box contains equipment to couple the subscriber drop cable to the building coaxial cables. A ground block coupler/splitter is included in the SA box that connects to the green wire leaving the box going to the electrical ground point and coaxial cables going to cable television outlets in the building.

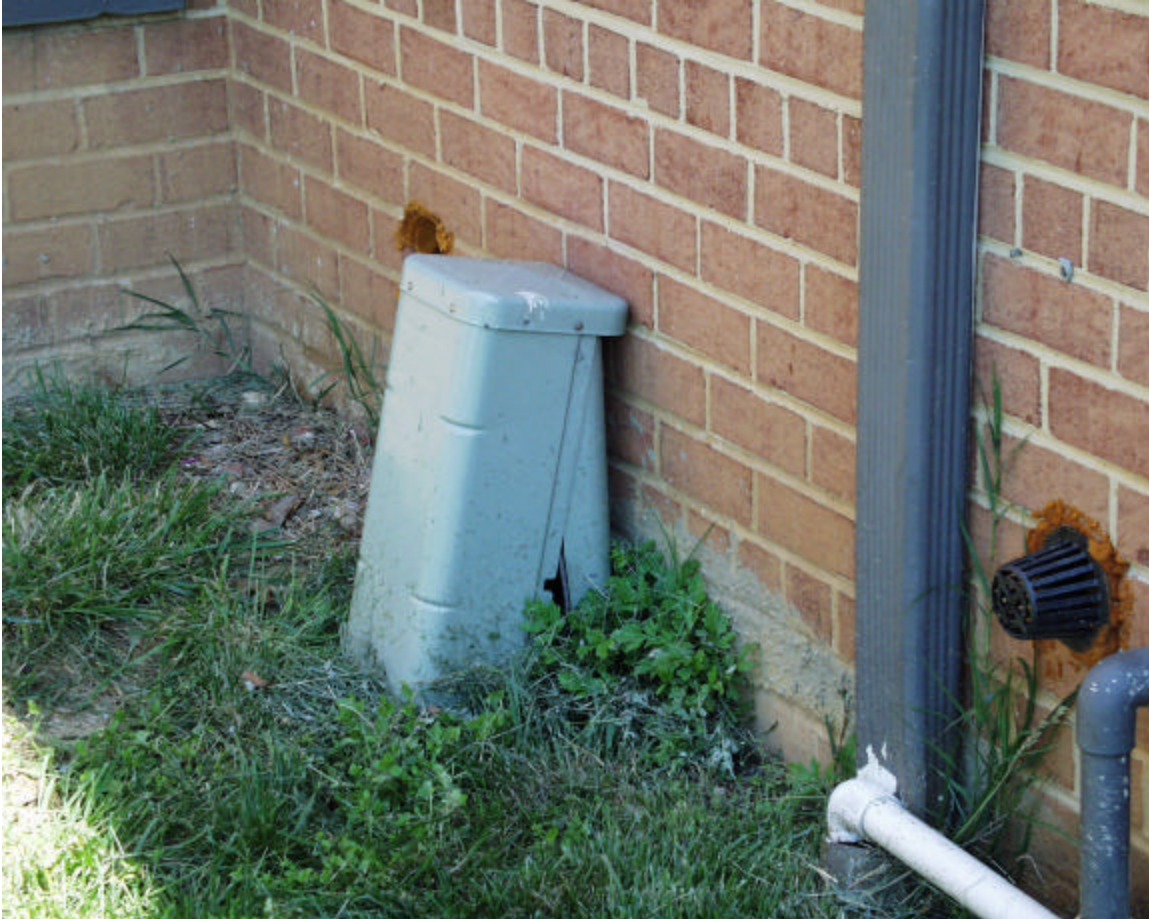
The above photograph was taken at 624 Mississippi Avenue, S.E. on May 3, 2000. It show an open pedestal, containing splitters and filter traps.

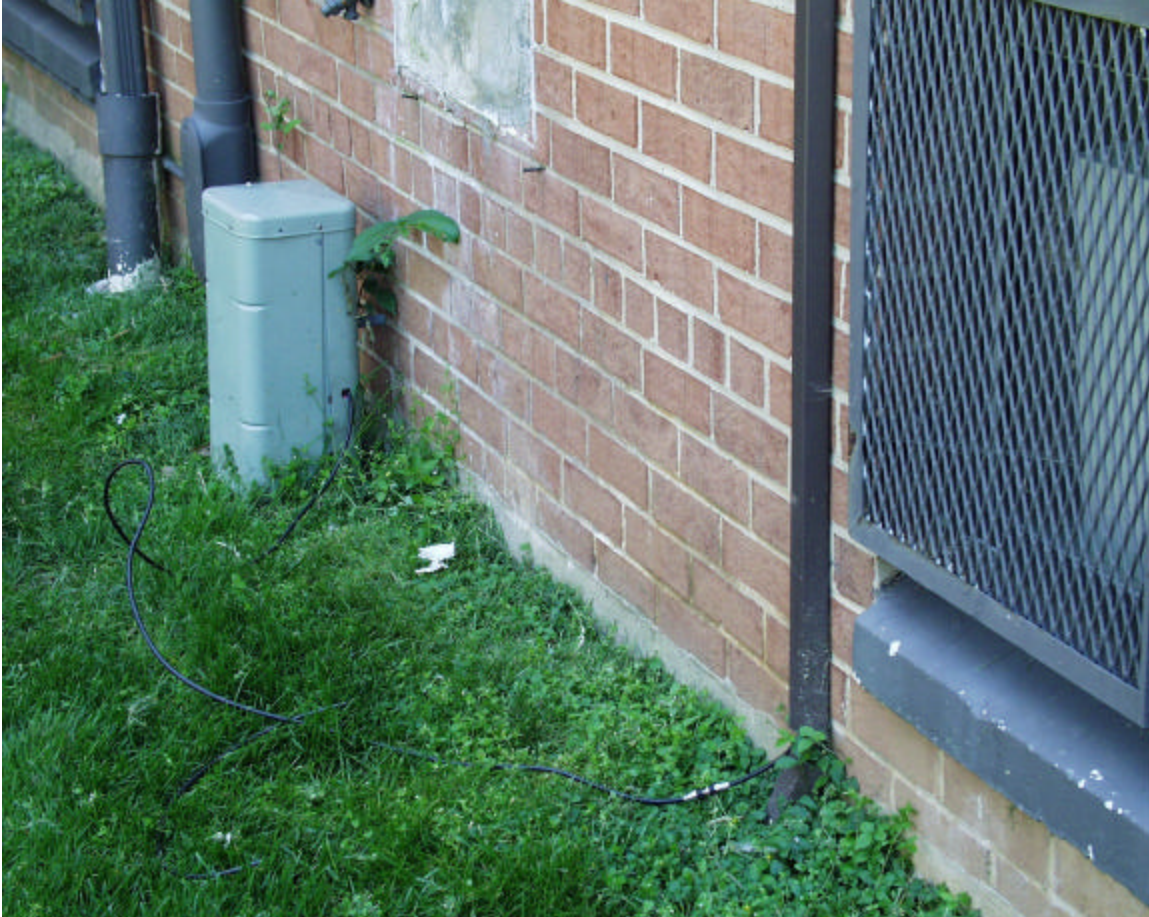
The above photograph was taken at 624 Mississippi Avenue, S.E. on May 3, 2000. It show a pedestal, containing splitters and filter traps, with a coaxial on the ground outside the wiremold.

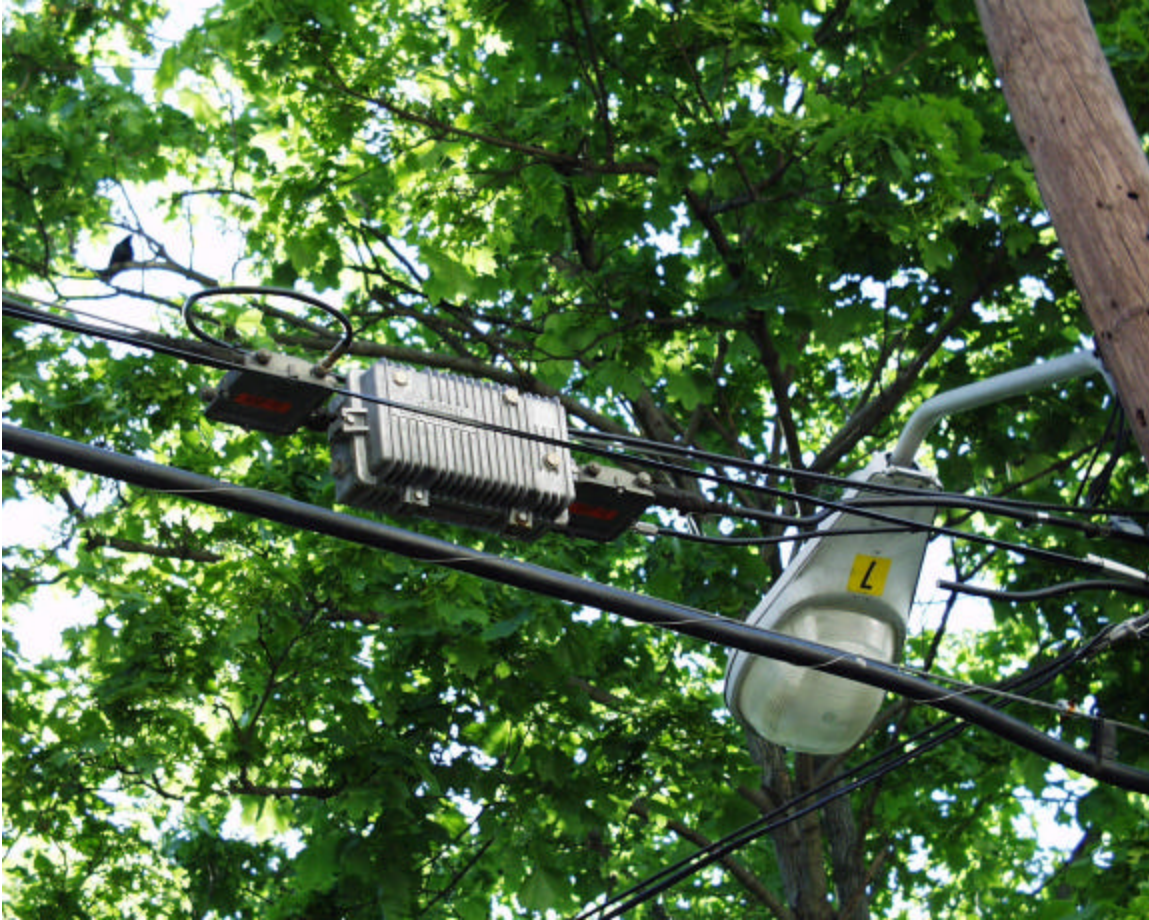
The above photograph was taken in the alley back of 3618 Connecticut Avenue, N.W. on May 3, 2000. It shows the coaxial cable amplifier and splitters used to provide the feed to this complex of buildings on Connecticut Avenue.

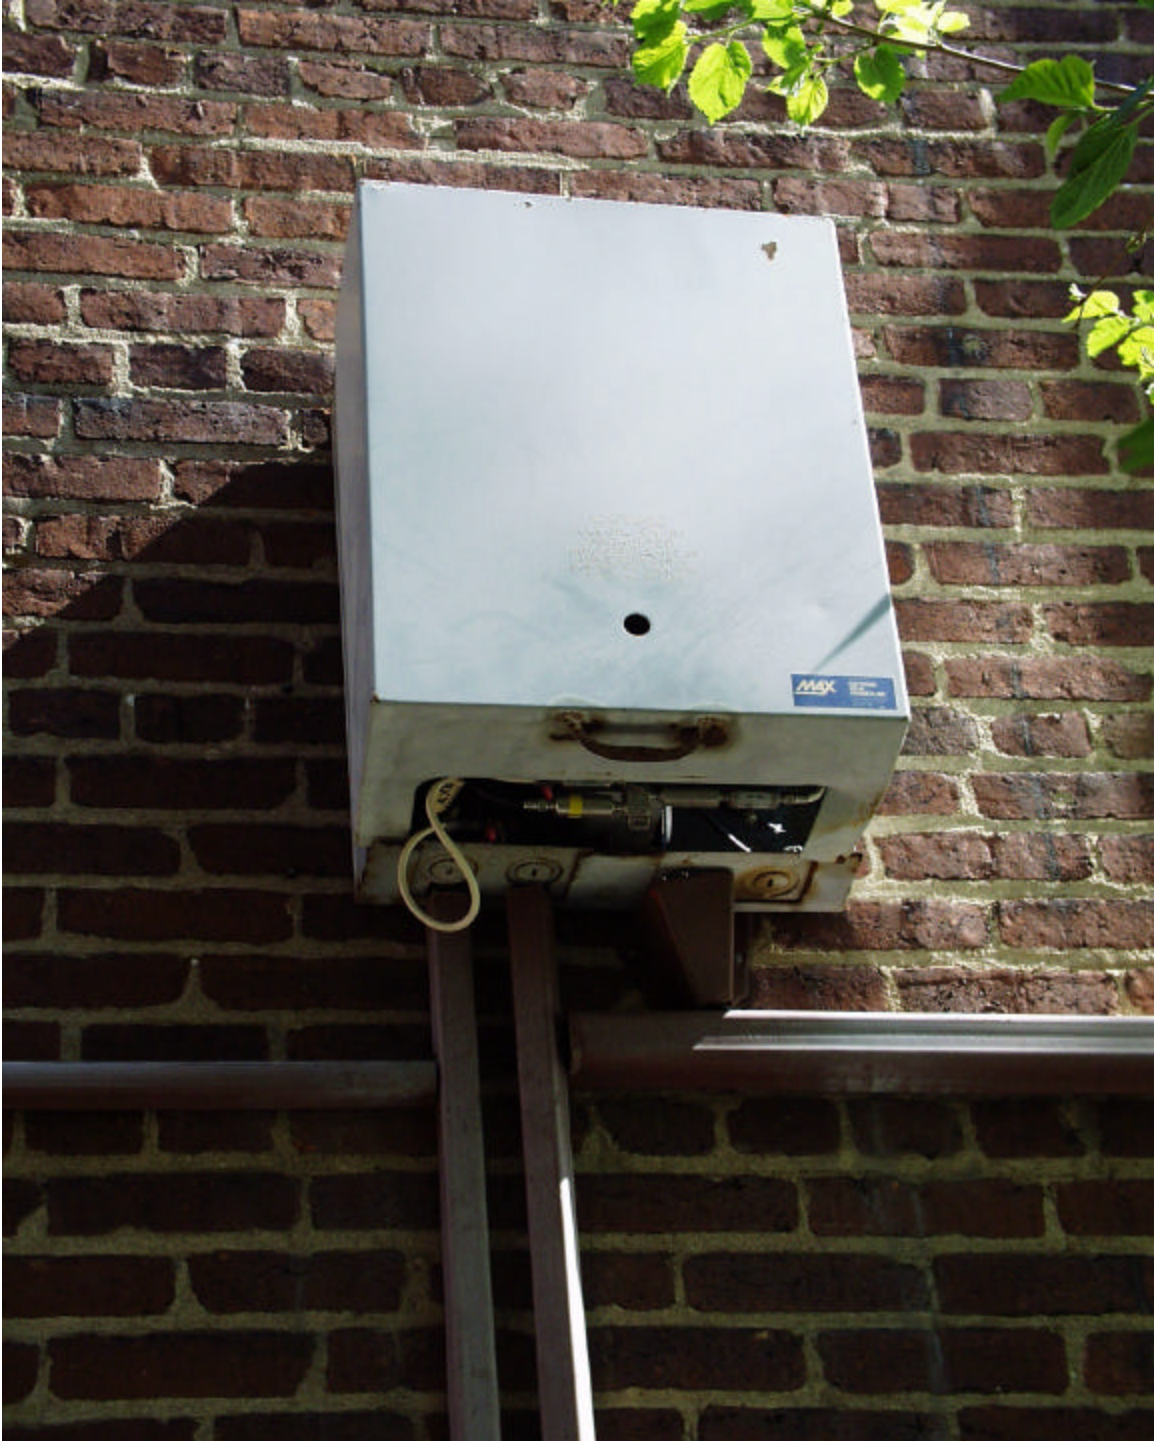
The above photograph was taken at 3620 Connecticut Avenue, N.W. on May 3, 2000. It shows an open lockbox, which contains splitters and filter traps.

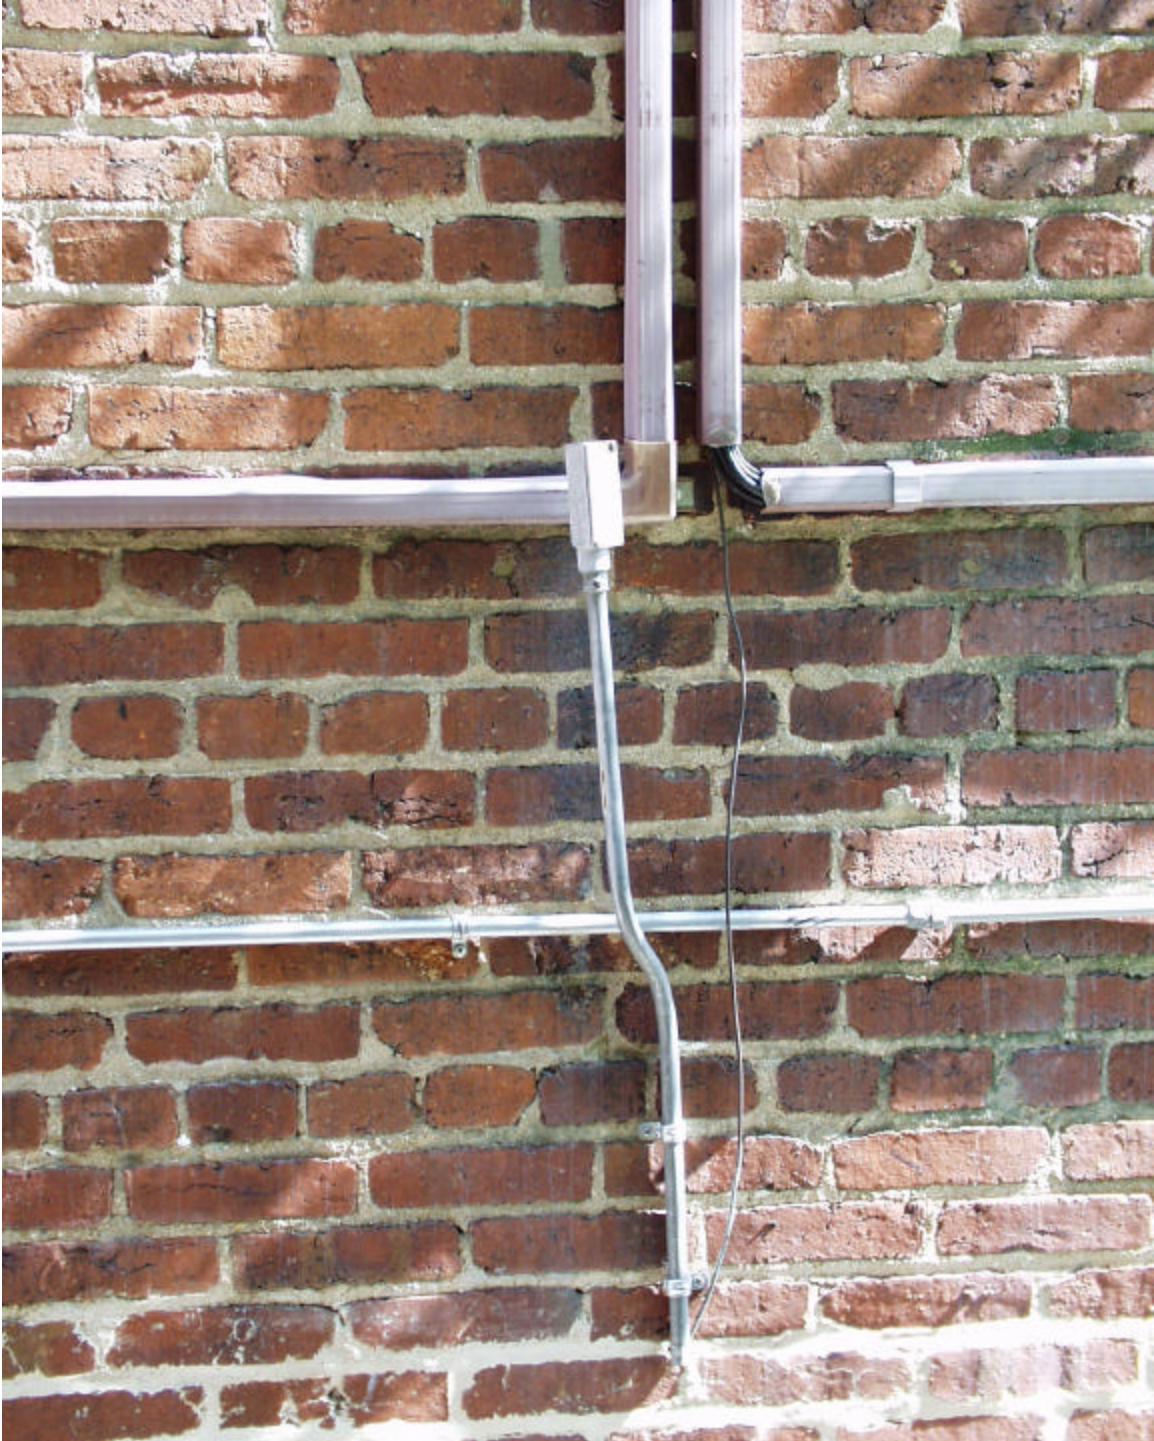
The above photograph was taken at 3620 Connecticut Avenue, N.W. on May 3, 2000. It shows open wire mold and the wire coming out of it appears to be the ground wire for the location drops.

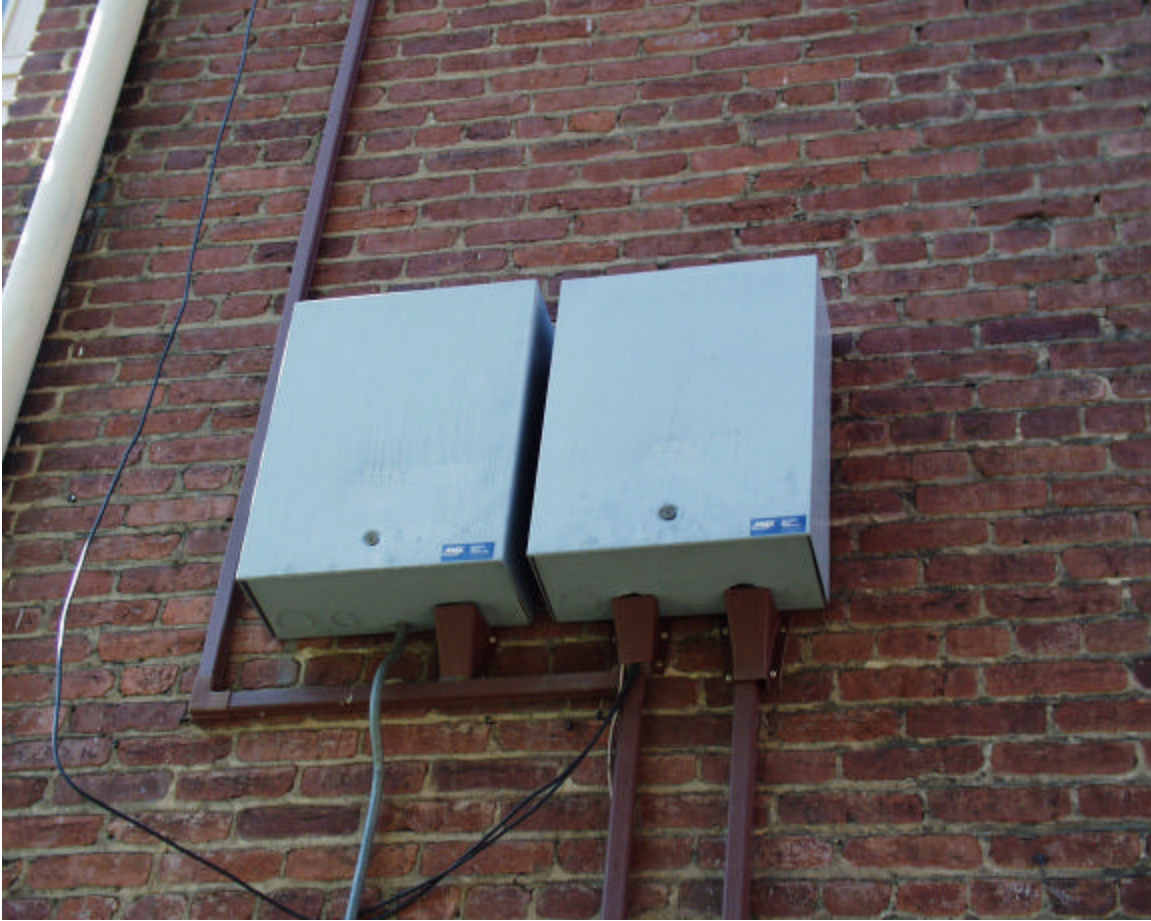
The above photograph was taken at 3622 Connecticut Avenue, N.W. on May 3, 2000. It shows a lockbox, which contains splitters and filter traps.

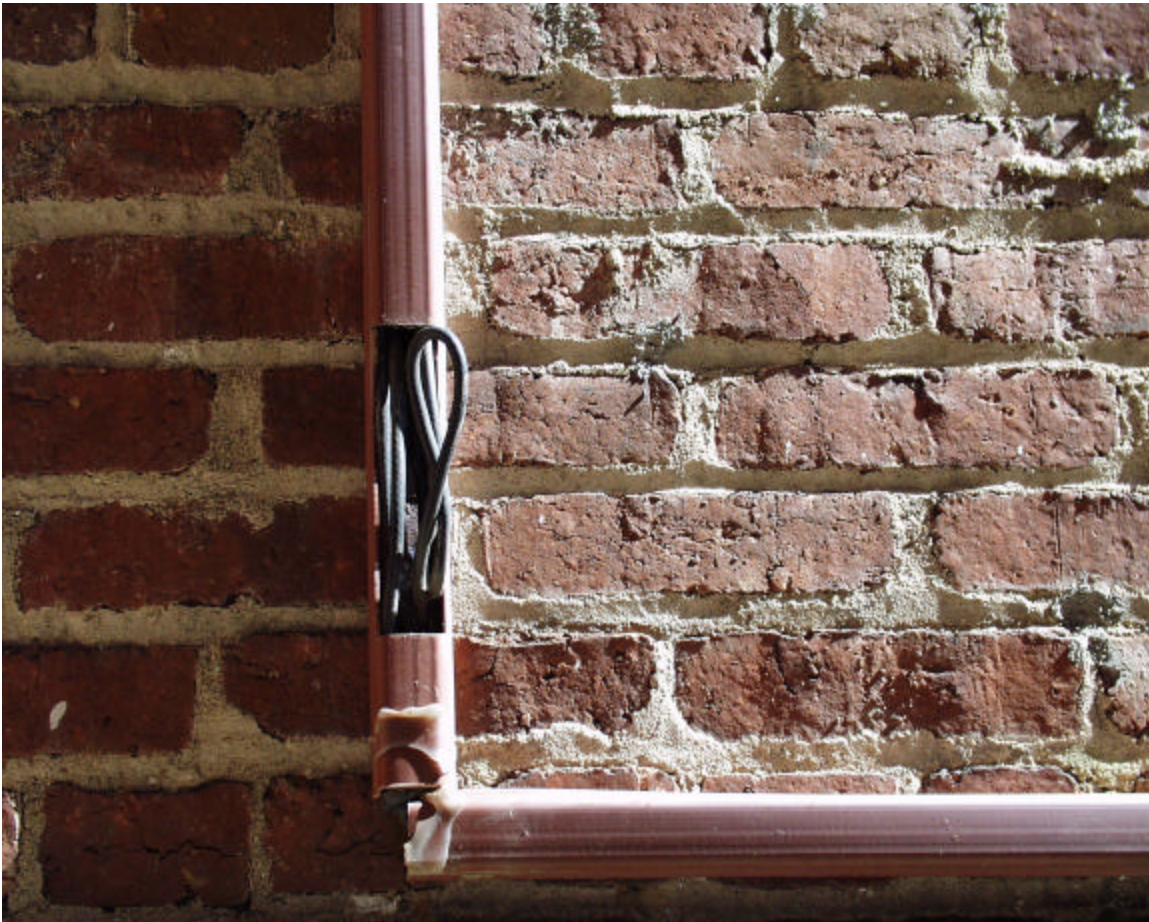
The above photograph was taken at 3620 Connecticut Avenue, N.W. on May 3, 2000. It shows broken open wire mold.

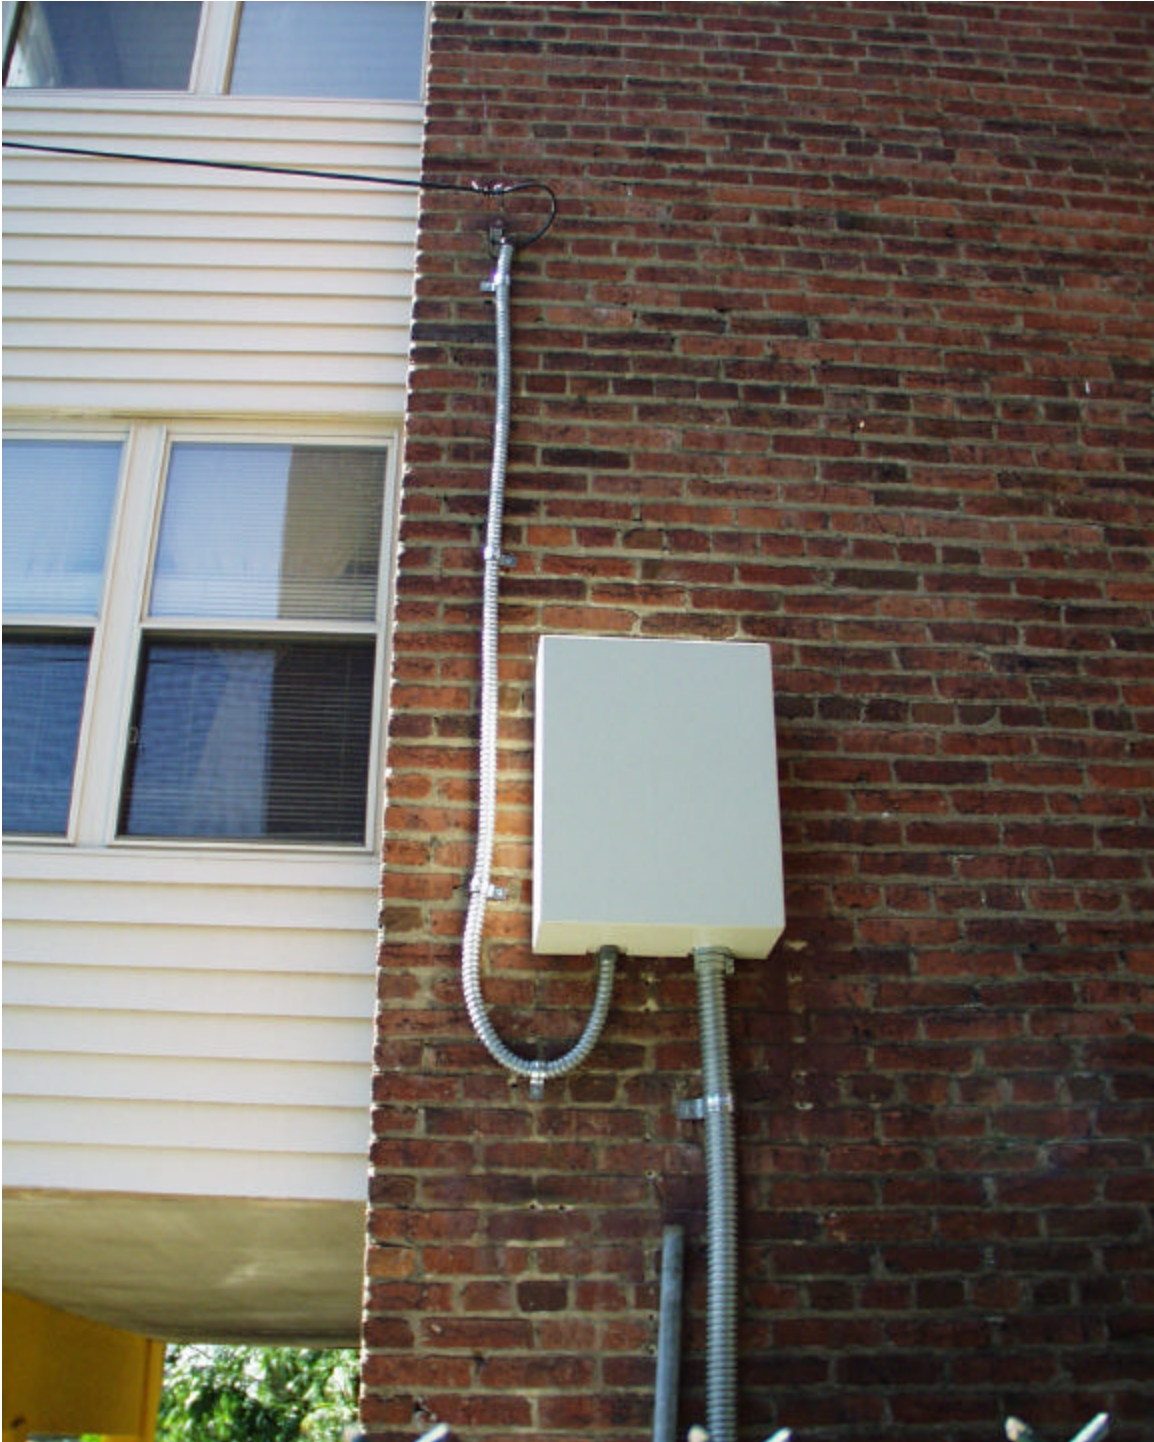
The above photograph was taken at 3618 Connecticut Avenue, N.W. on May 3, 2000. It shows a newly installed lockbox containing splitters and filter traps.

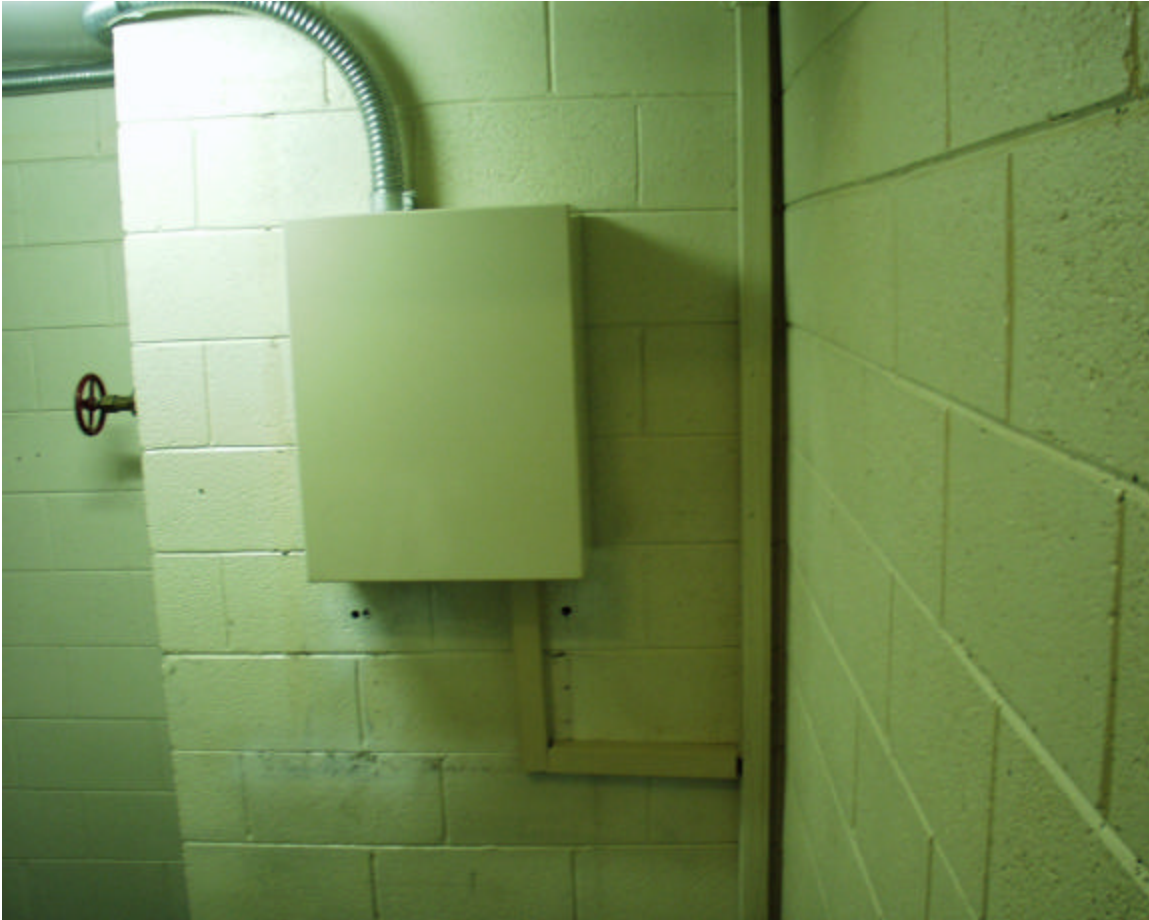
The above photograph was taken at 4660 MLK Avenue, S.W. on May 3, 2000. It shows a lockbox in a stairwell. The lockbox contains splitters and filter traps.

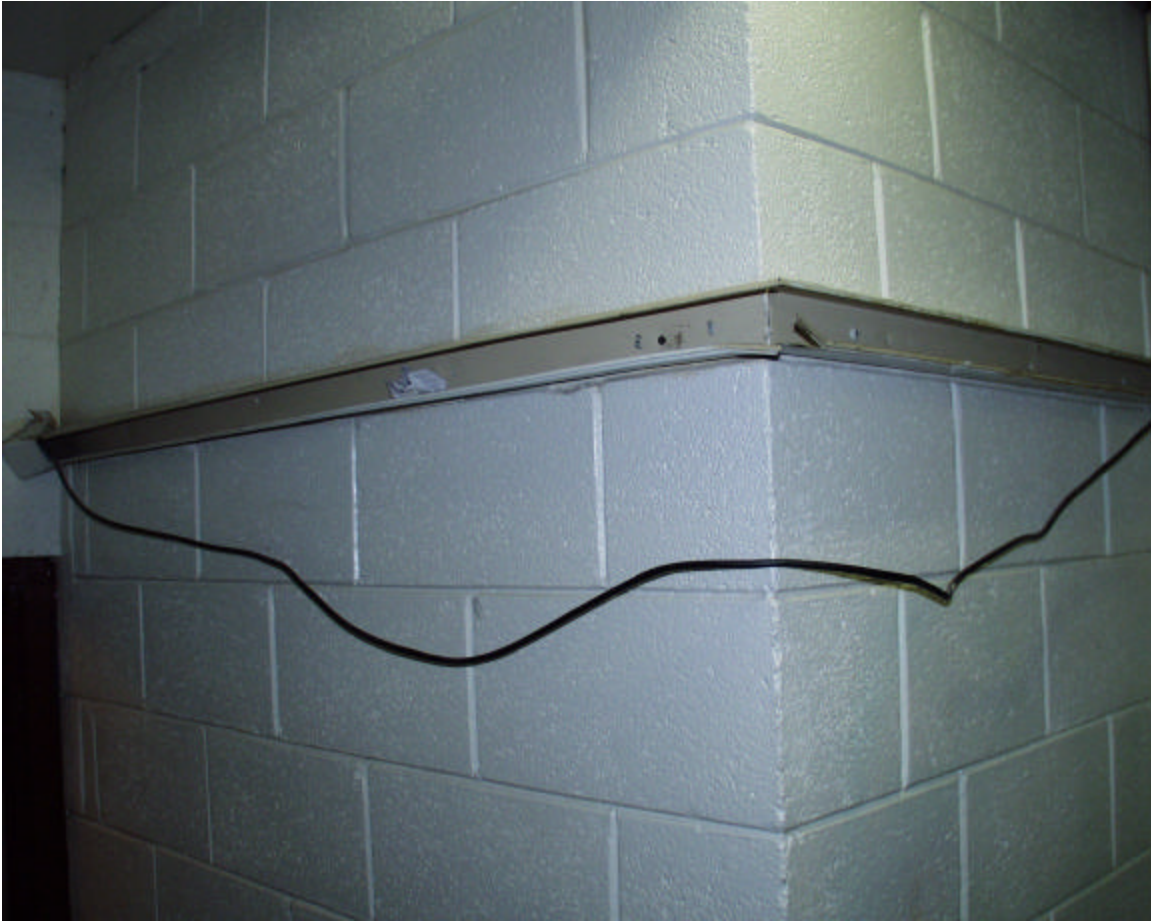
The above photograph was taken at 4660 MLK Avenue, S.W. on May 3, 2000. It shows broken open wiremold with a coaxial cable hanging loose in stairwell.

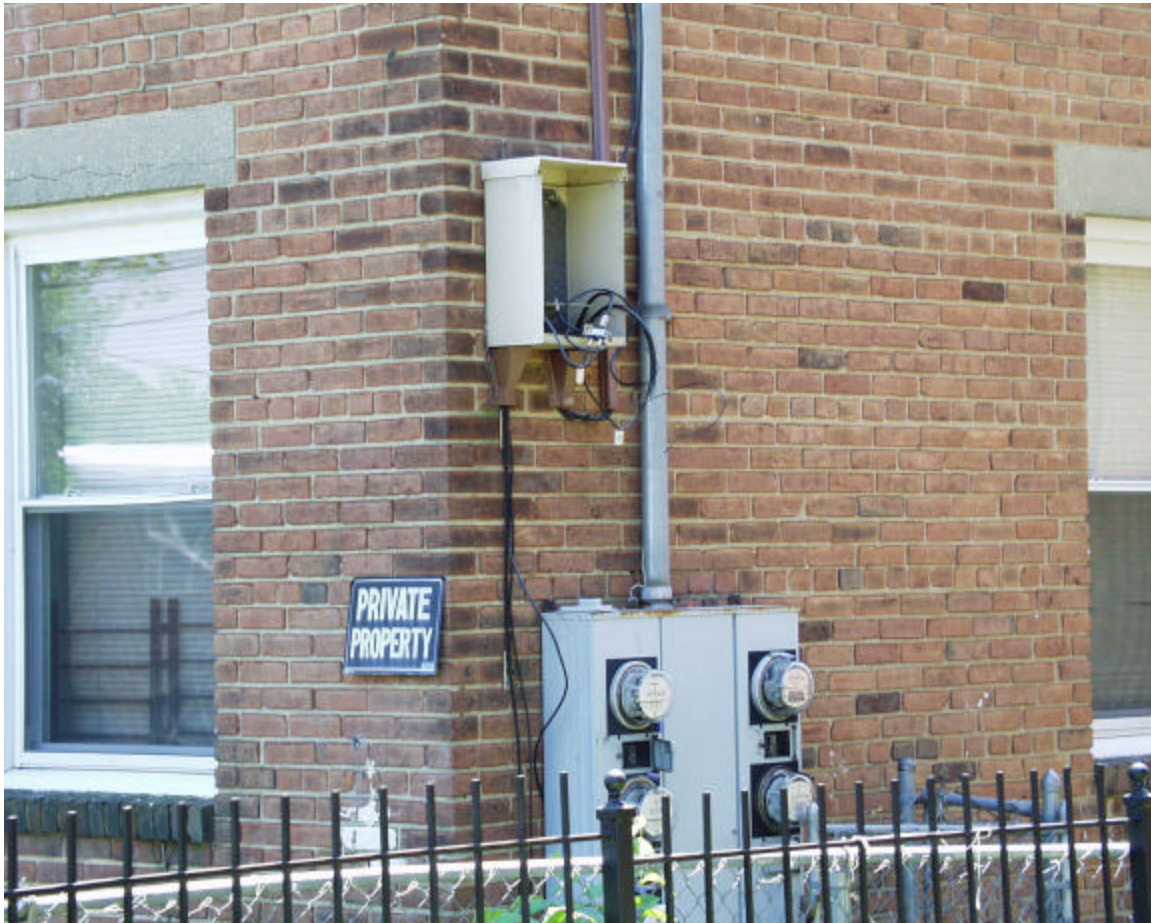
The above photograph was taken at 58 Galveston Street S.W. on May 3, 2000. It shows a splitter and filter traps in an open lockbox, without a cover.

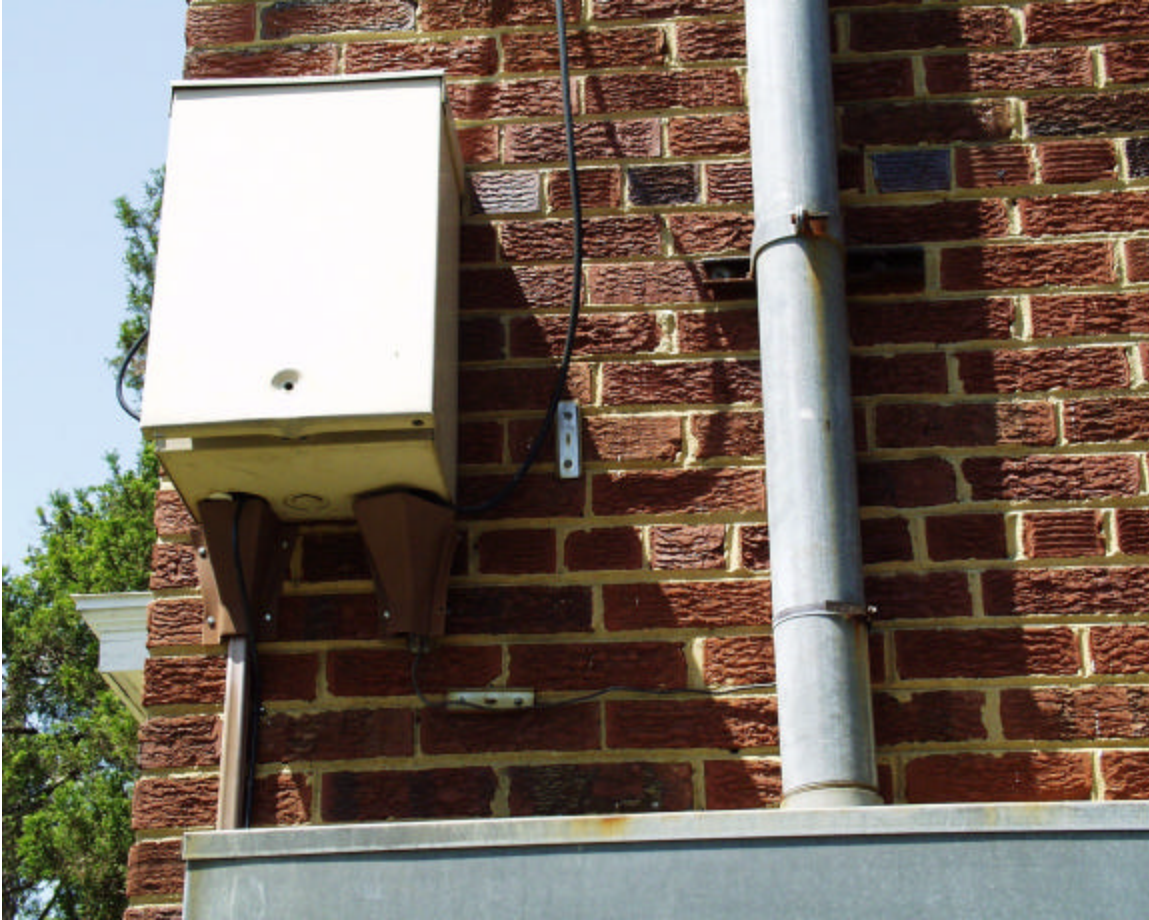
The above photograph was taken at 101 Galveston Street S.W. on May 3, 2000. It shows an open lockbox.

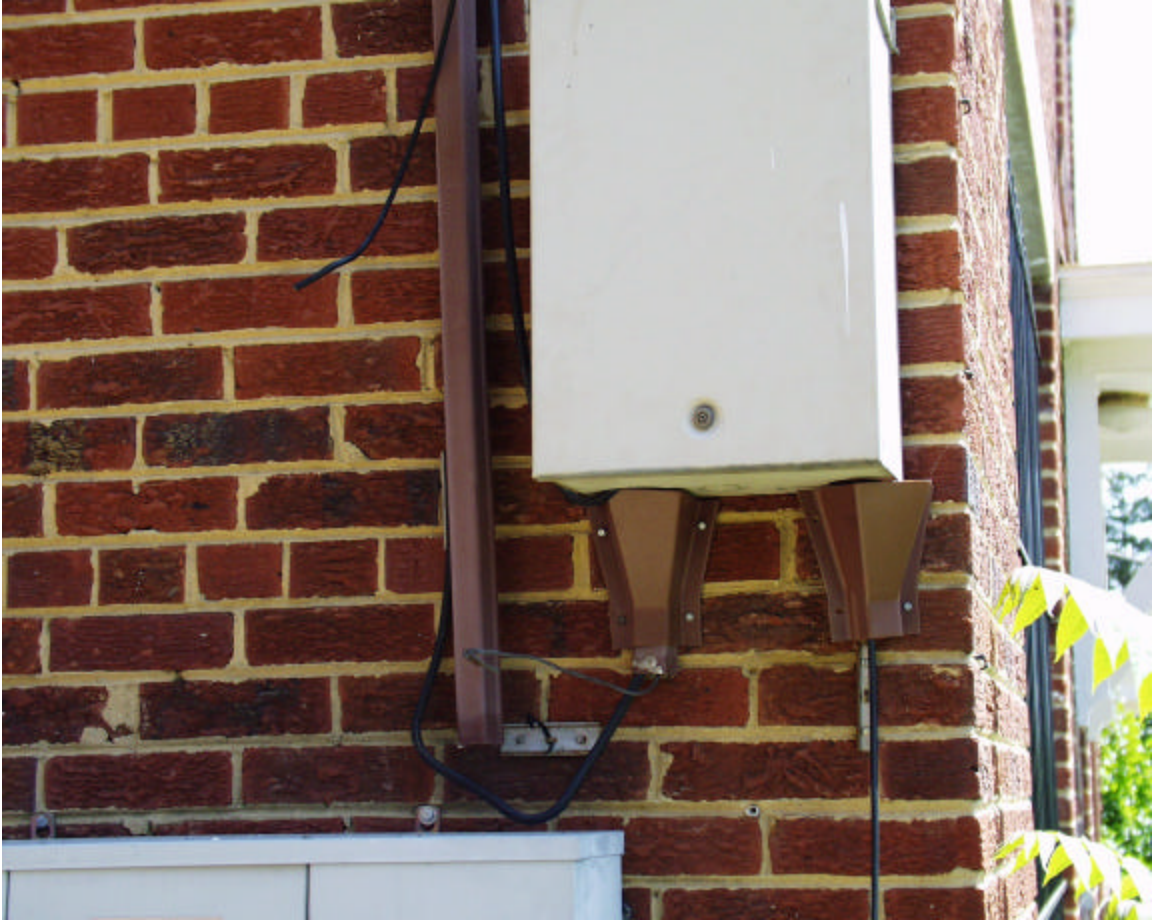
The above photograph was taken at 63 Galveston Street S.W. on May 3, 2000. It shows a lockbox.

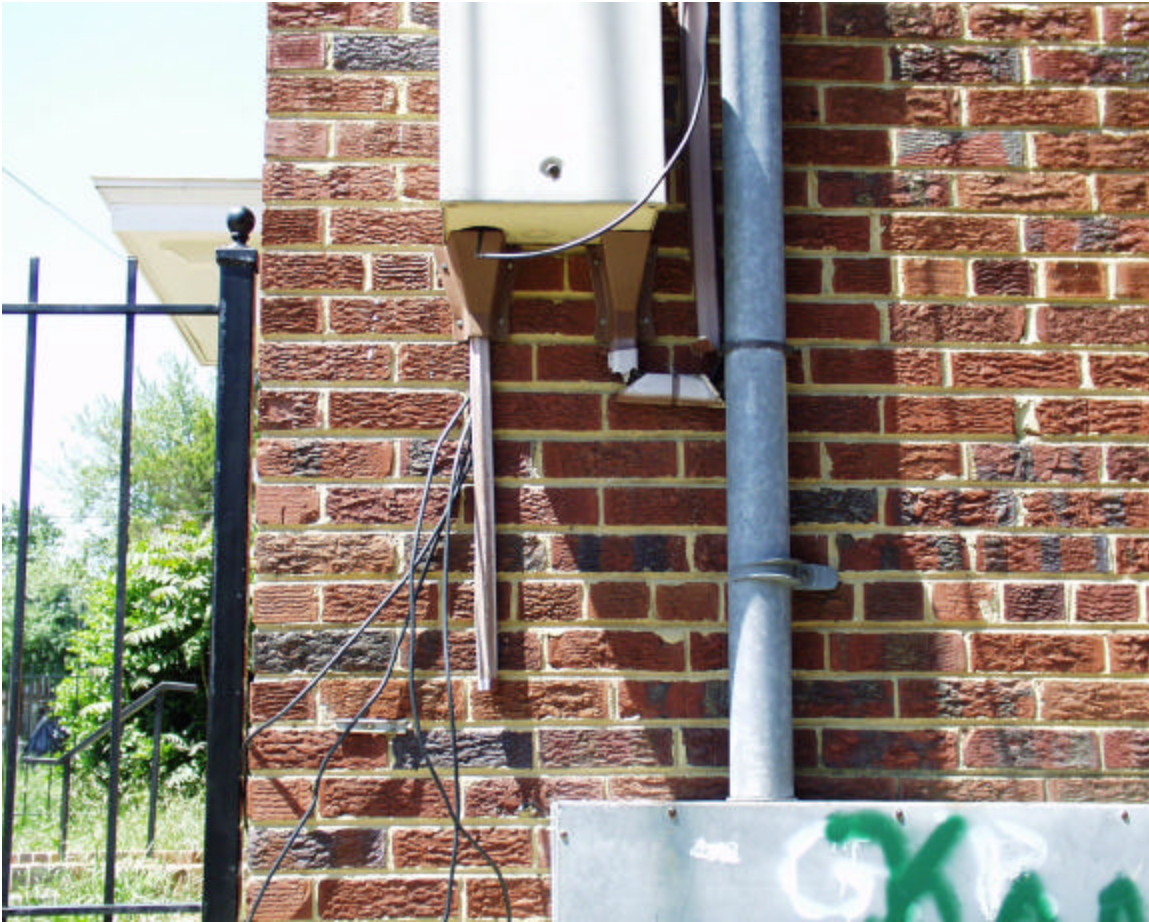
The above photograph was taken at 59 Galveston Street S.W. on May 3, 2000. It shows a lockbox with broken wiremold and loose cables.

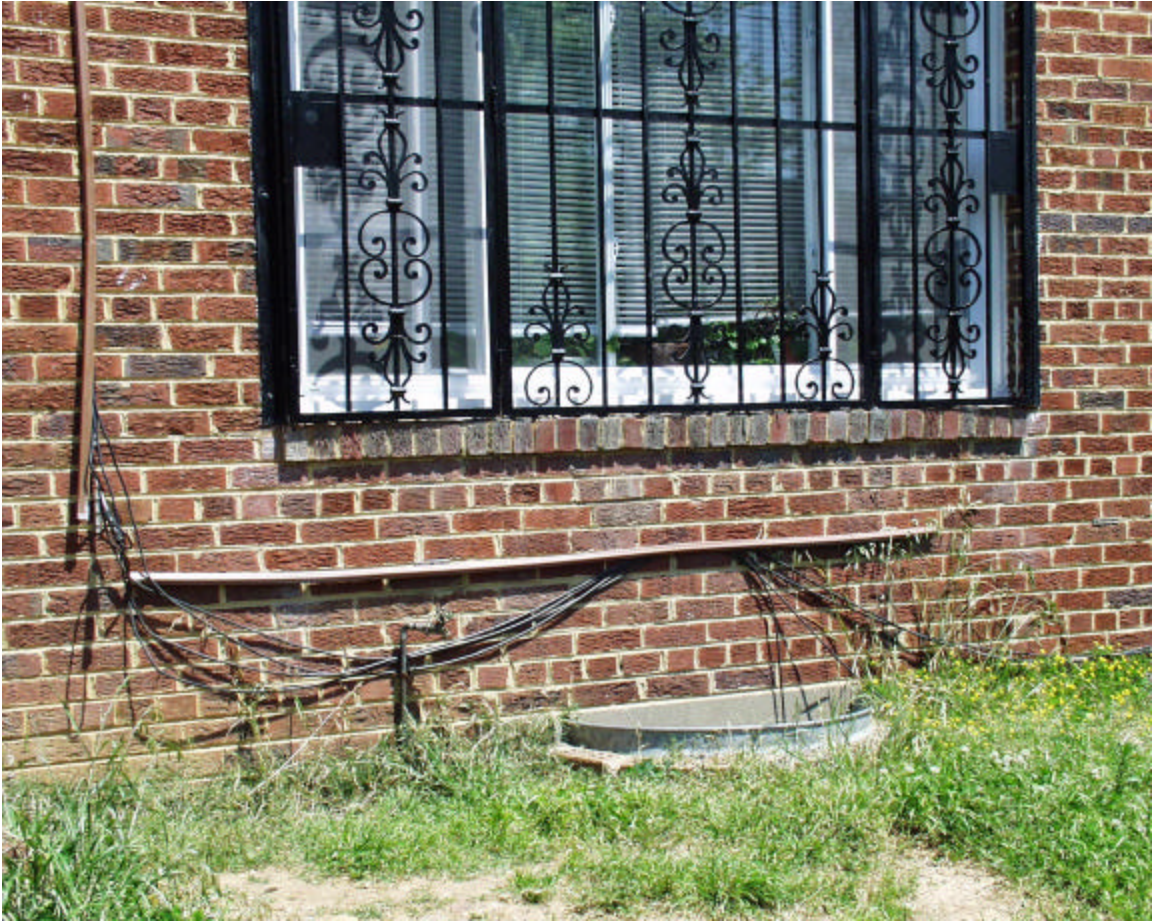
The above photograph was taken at 59 Galveston Street S.W. on May 3, 2000. It shows open wiremold and loose cables.

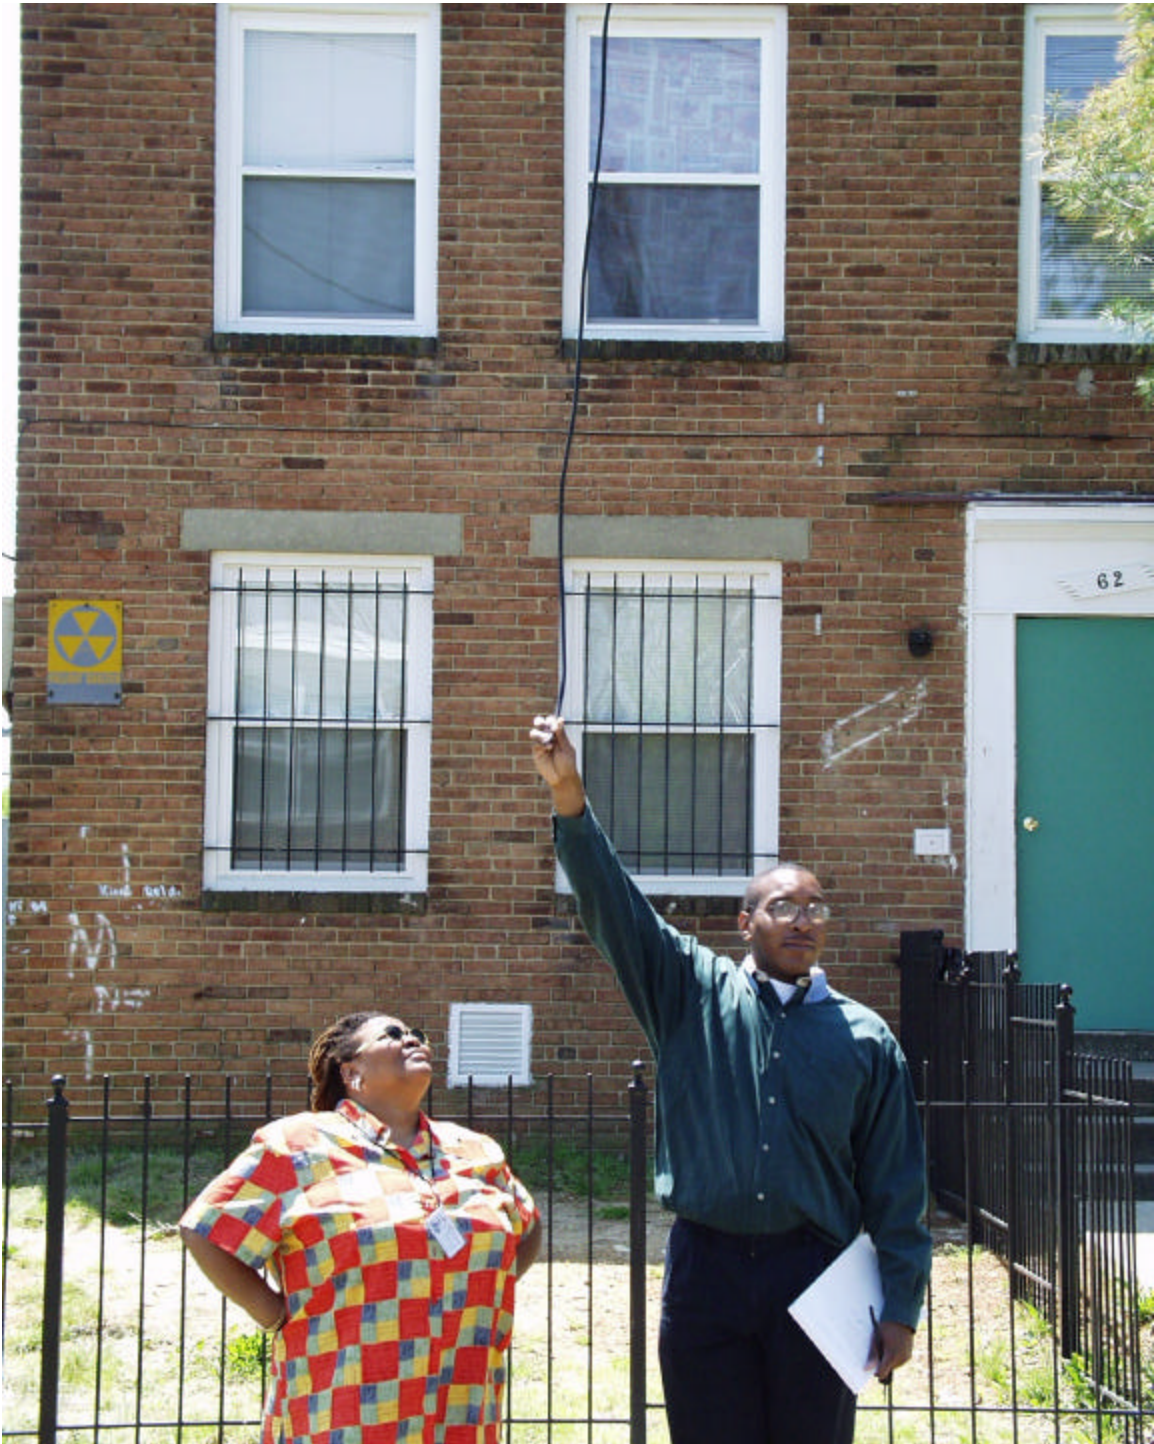
The above photograph, taken in front of 62 Galveston Street S.W. on May 3, 2000, shows a loose coaxial cable hanging low over the sidewalk area.
