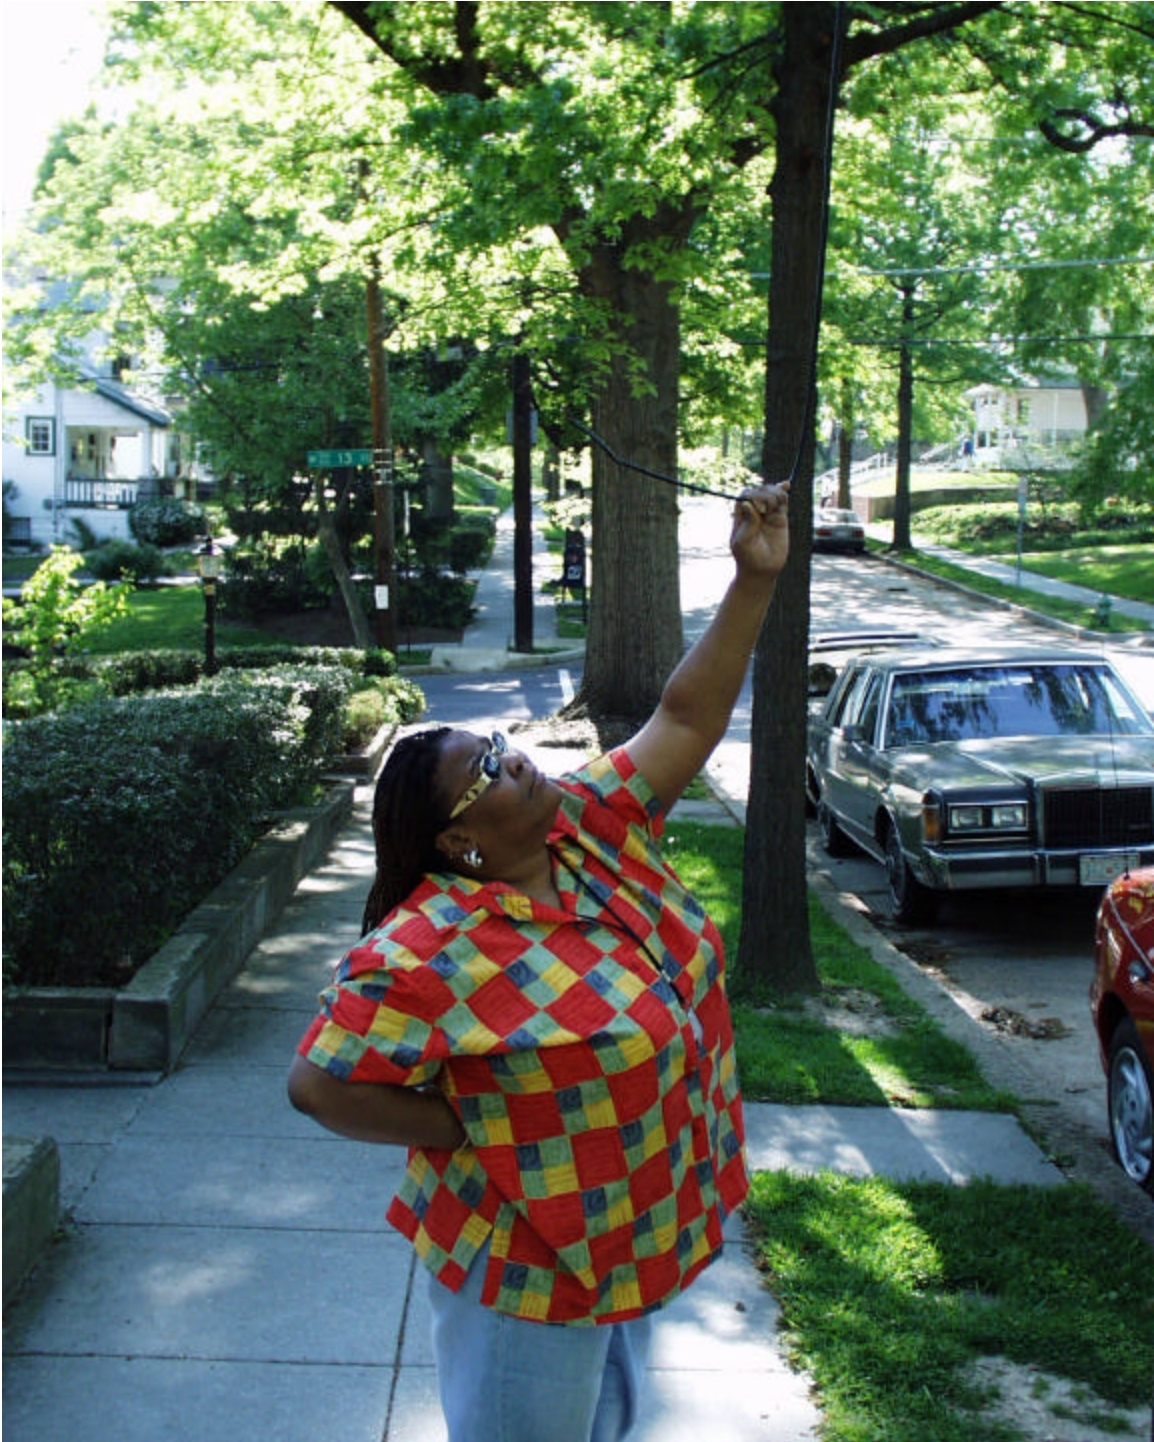
The above photograph, taken in front of 1305 Lawrence Street, N.E. on May 3, 2000, shows a loose coaxial cable hanging low over the sidewalk area.

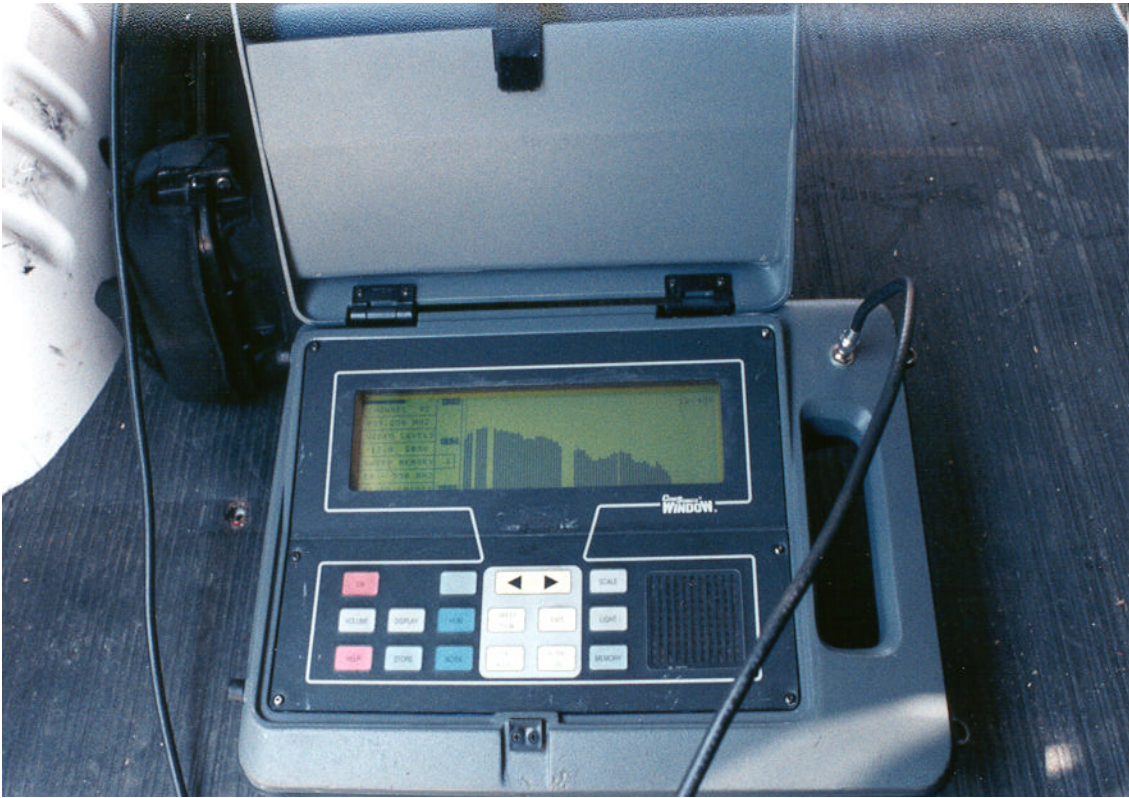
The above photograph shows a signal level meter that was used during the tests conducted primarily in 1998 and 1999. The display is showing the signal levels of the channels which is an indication of the frequency response of the distribution system.

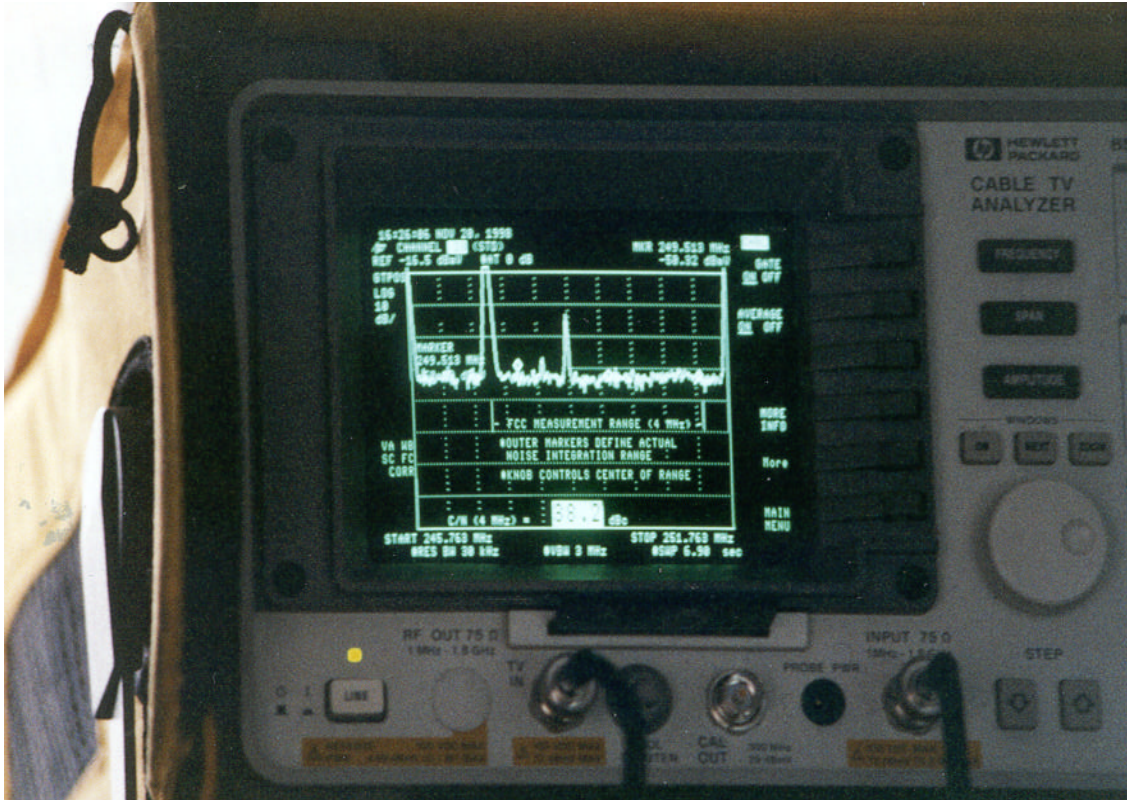
The above photograph shows a Cable TV Analyzer (typically called a spectrum analyzer) that was used during the tests conducted primarily in 1998 and 1999. The display is showing the Carrier to Noise Ratio being measured on a channel. This measurement quantifies the amount of noise, appearing like snow, in the pictures.

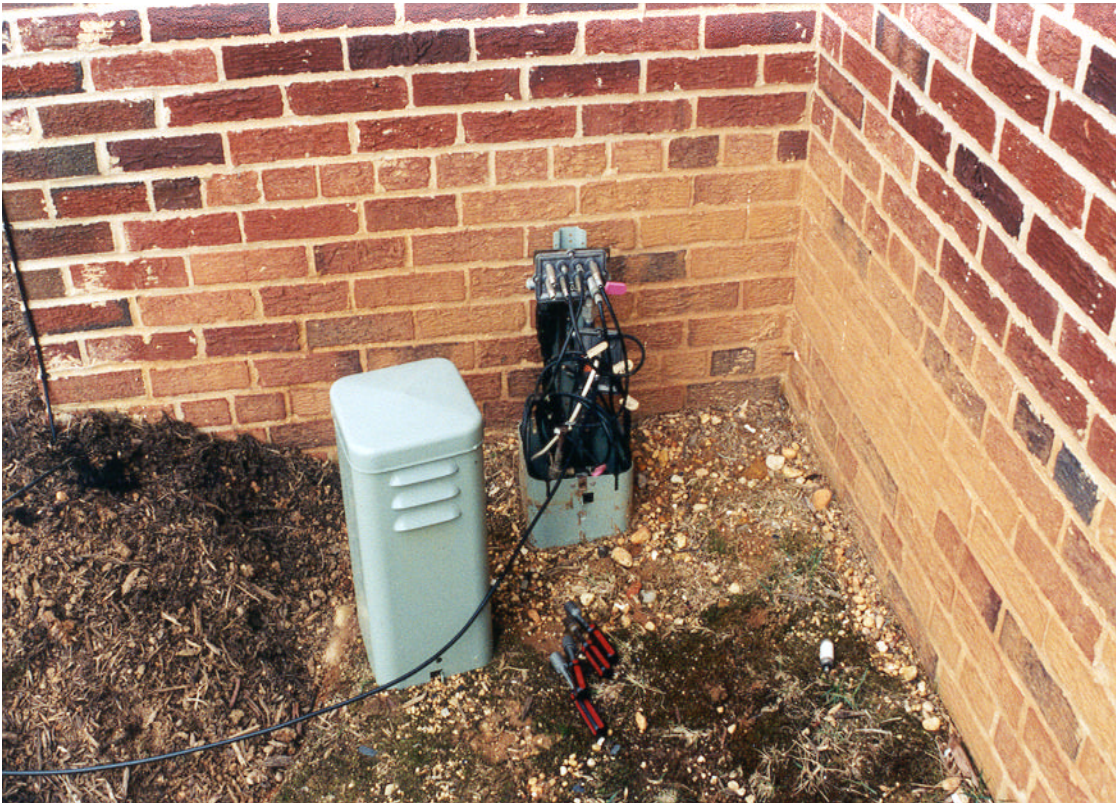
The above photograph, taken in 1998 at the Fort Lincoln Townhouses, shows a subscriber pedestal used in the underground plant. An eight port subscriber tap box and some filter traps can be seen.

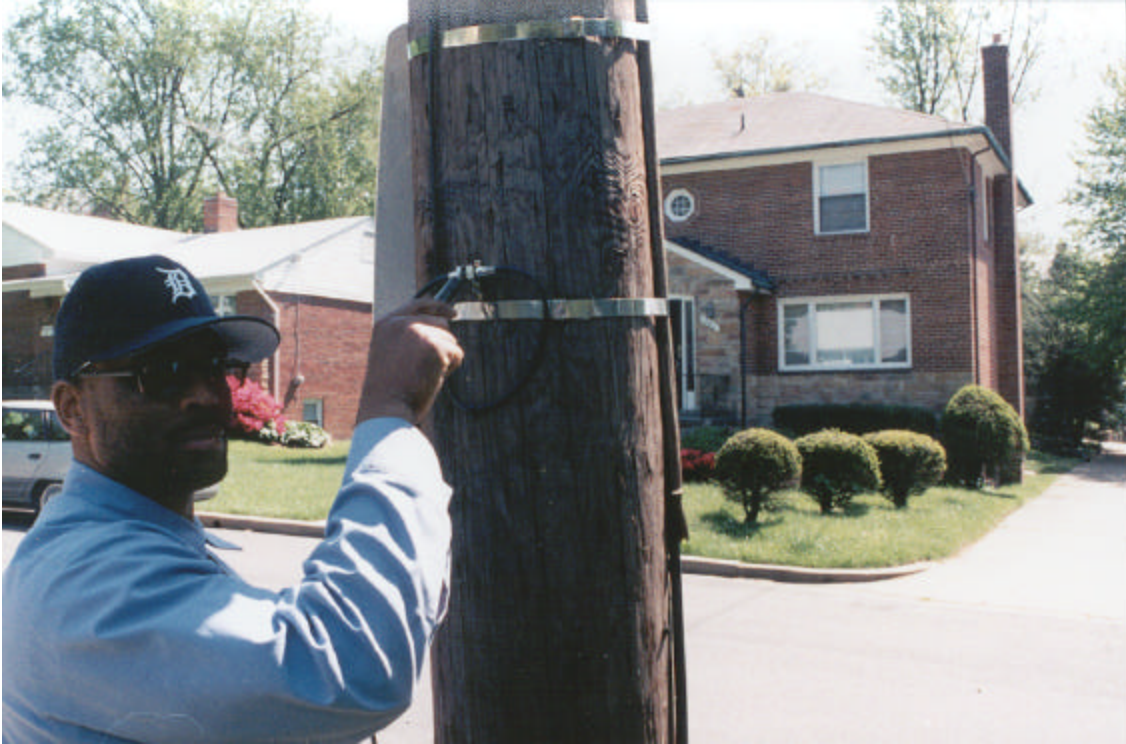
The above photograph, taken in 1998, shows an example of test point location couplers that have been installed on several poles throughout the District. Their installation facilitates testing the distribution system, without the need of climbing the pole or using a bucket truck each time.

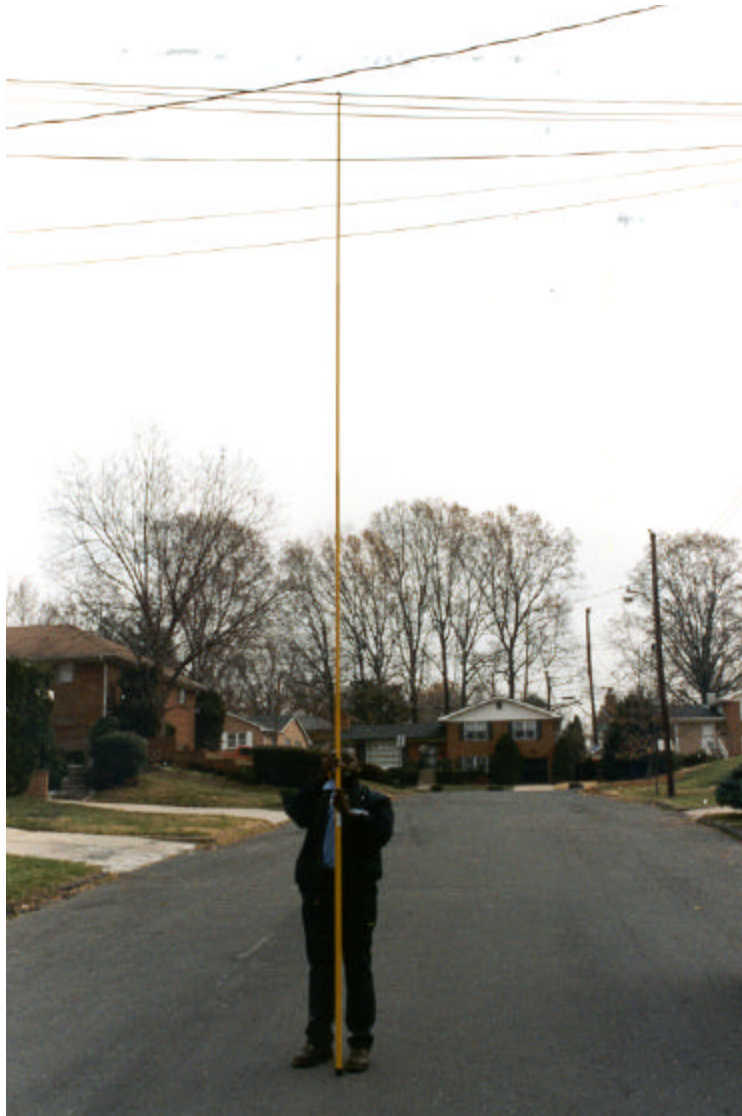
The above photograph, taken in 1998, shows an example of a special measurement pole used to check the height of cables above the streets, ground, and walkways.

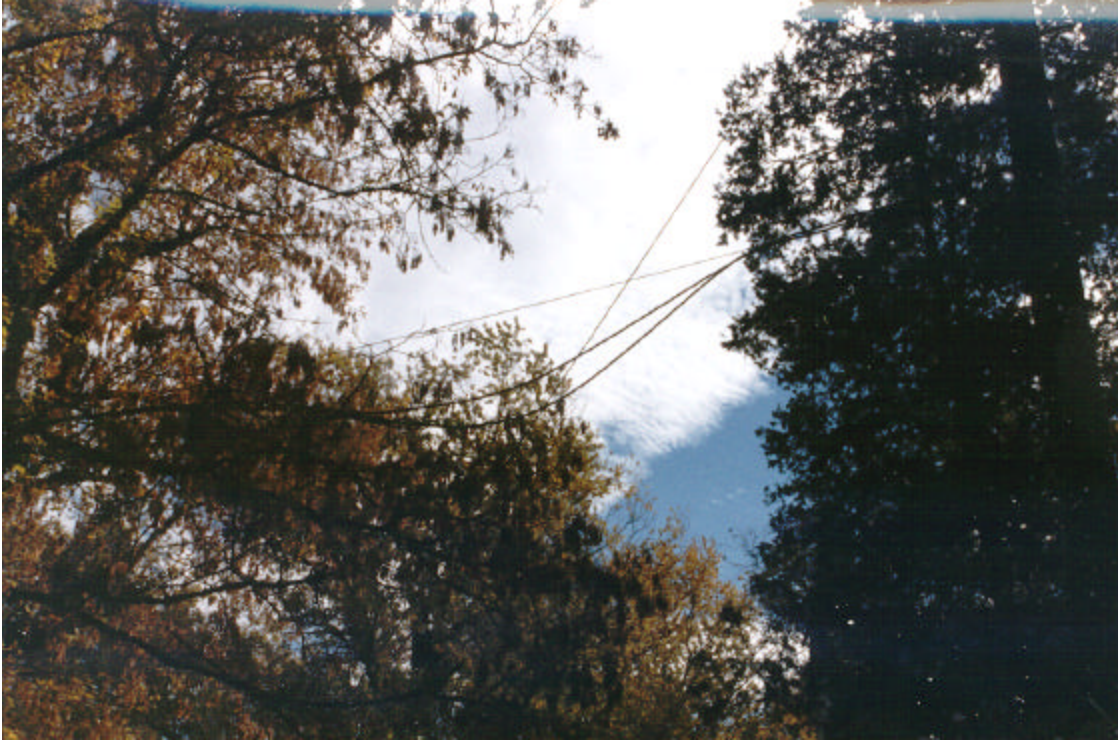
The above photograph, taken in 1998 near Potomac and Newark St, NW, shows some damaged cables. This particular damage permitted signal leakage of about 700 $\mu\text{V}/\text{m}$.

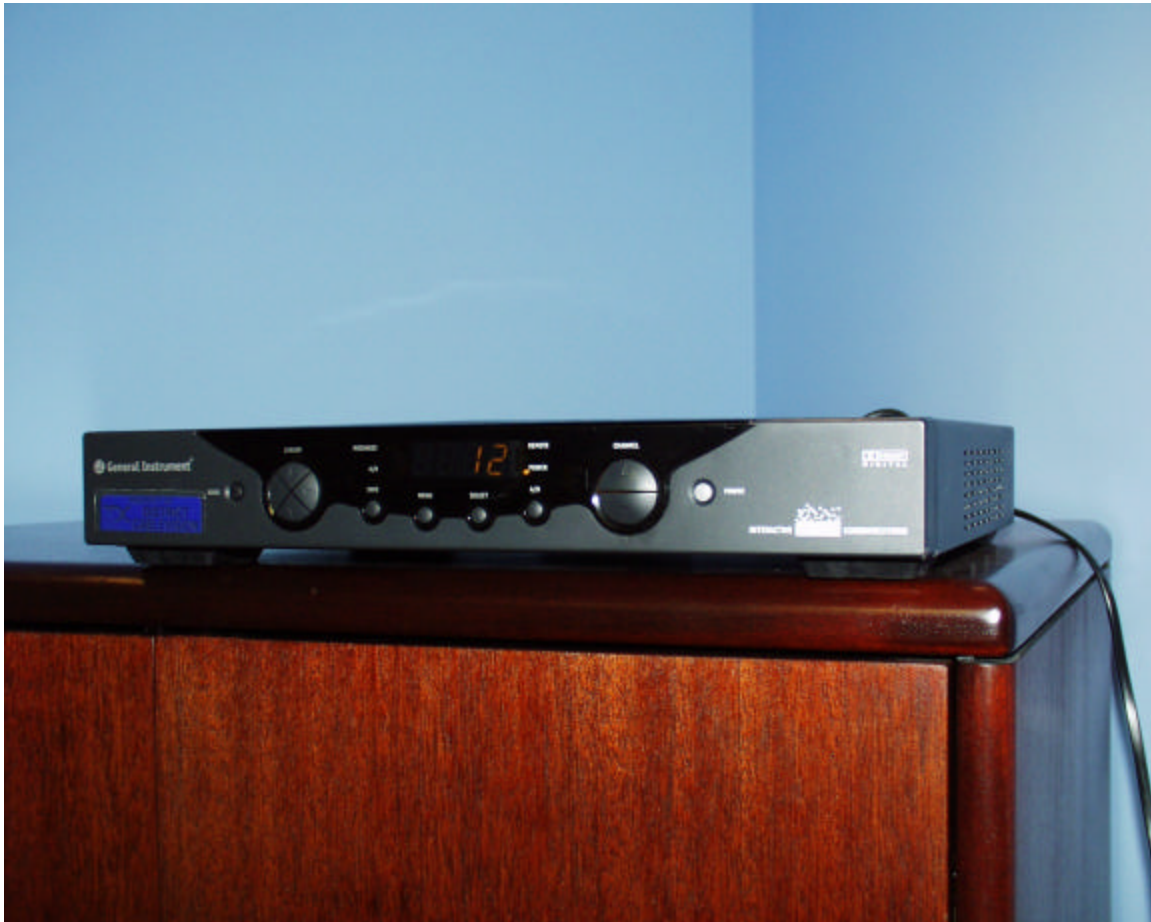
The above photograph was taken on May 3, 2000. It shows a view of the new digital converter box.

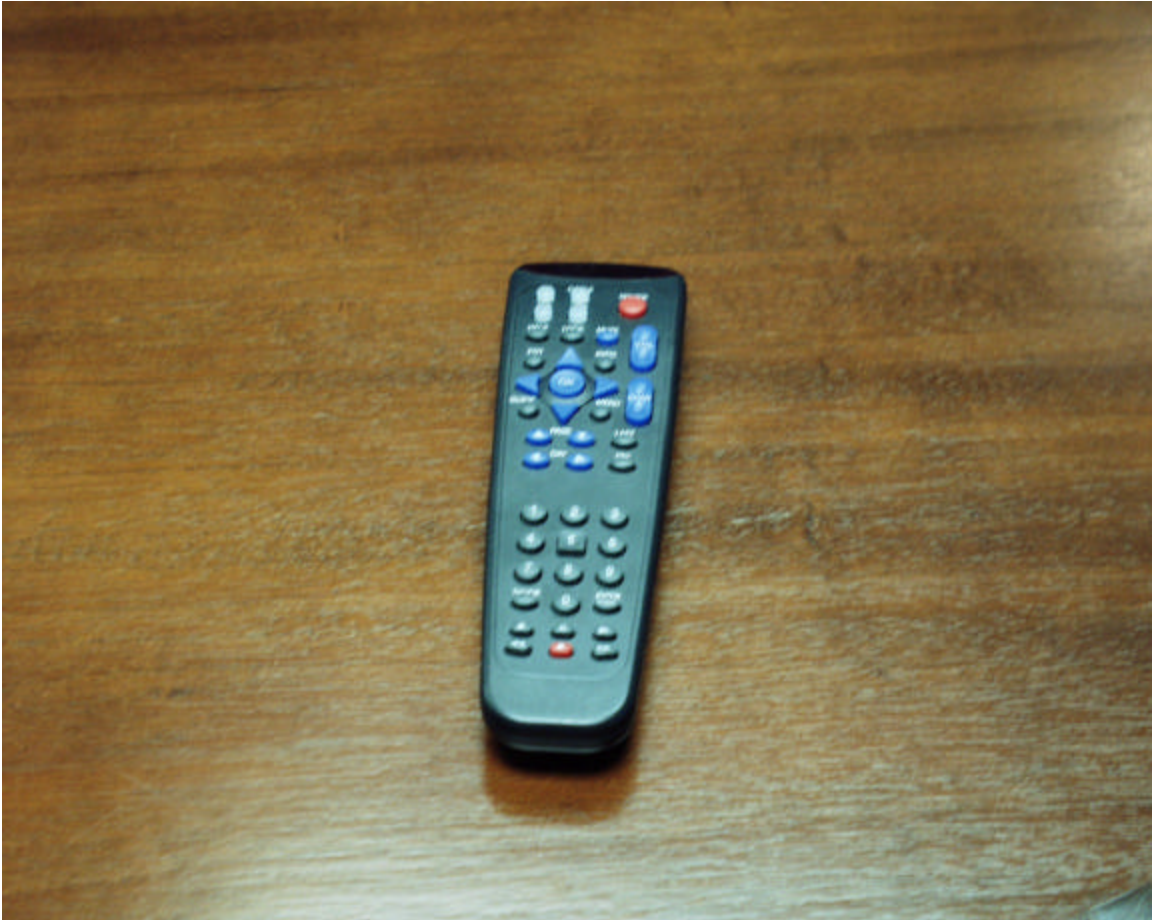
The above photograph was taken on May 3, 2000. It shows a view of the remote control used in conjunction with new digital converter box.

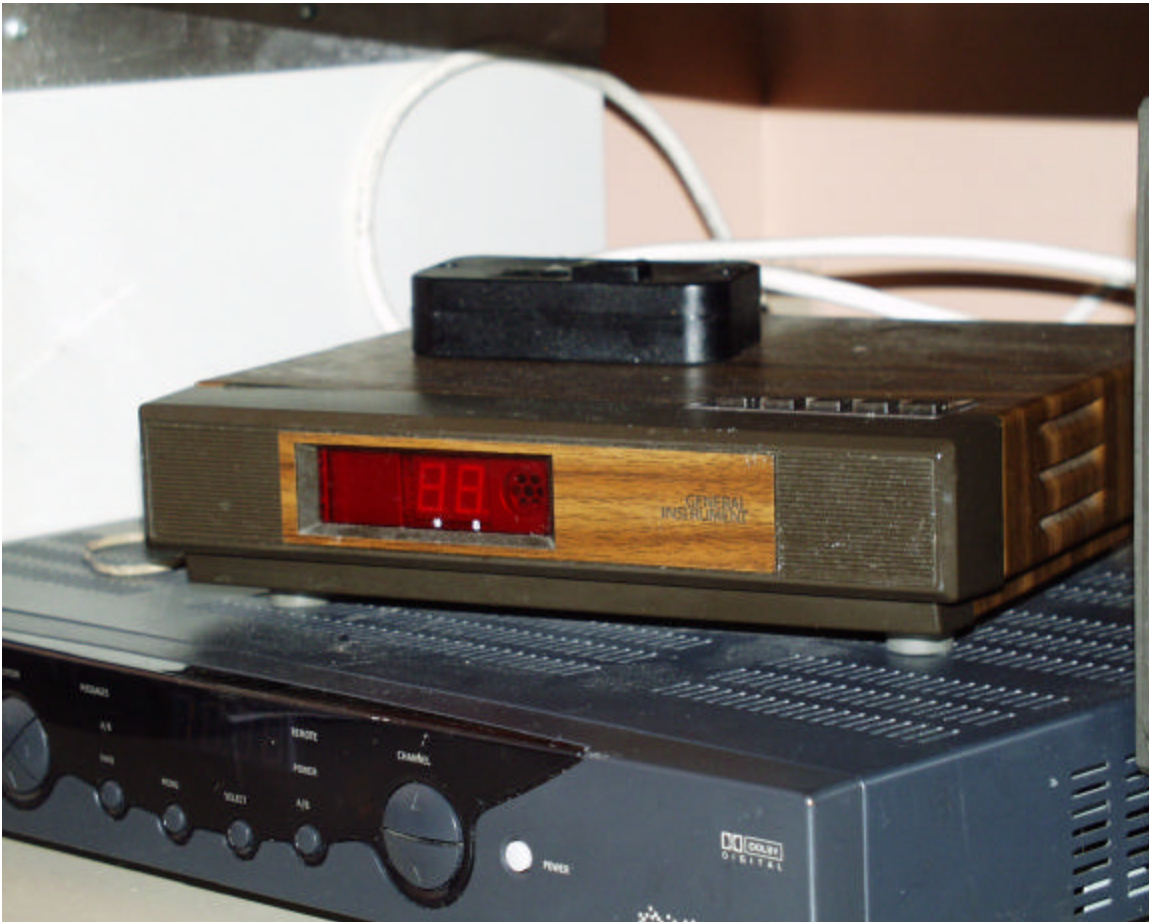
The above photograph was taken on May 3, 2000. It shows a view of an addressable converter box setting on top of a new digital converter box.
